**Lake of the Woods County
Bostick Creek Flooding and Sediment
Source Investigation and Sediment
Reduction Study**

June 2005

HDR Engineering, Inc.

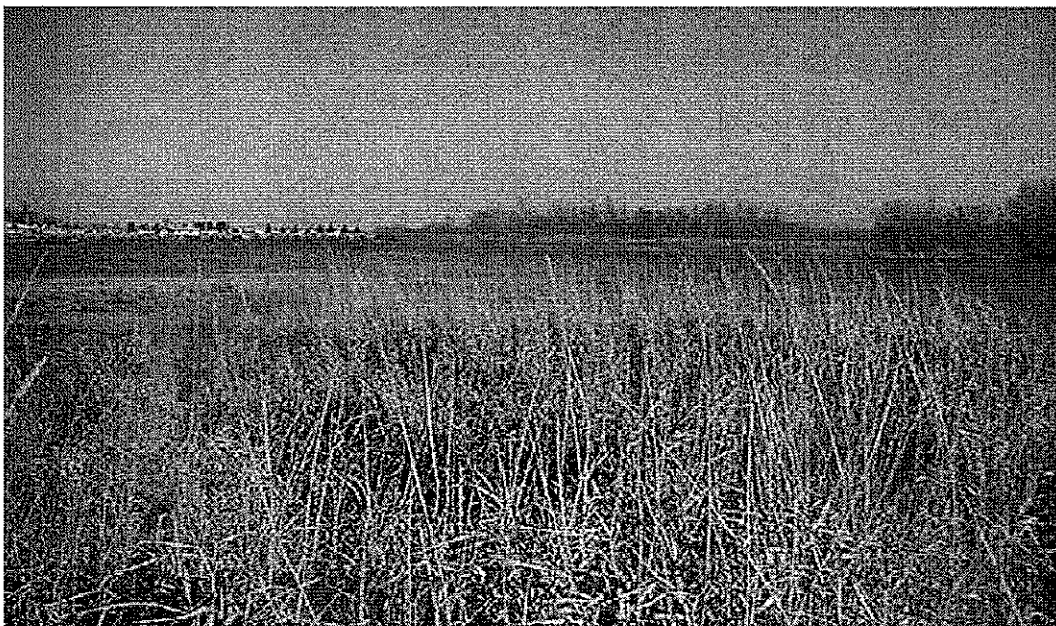
Figure 3 – Bostick Bay Looking North near County Road 8

Bostick Creek and its tributaries have been a source of localized erosion, sediment deposition, and flooding problems for many years. Specifically, Judicial Ditch 28 (JD 28), which essentially connects Canfield Creek to Bostick Creek and drains through the degraded Graceton Bog, has been prone to high flows and channel instability. In turn, Bostick Creek itself is known to threaten downstream homes and roads with high flows. Finally, Bostick Bay on Lake of the Woods, which functions as the outlet for Bostick Creek, has been slowly filling in with sediment and vegetation making navigation increasingly difficult (Figures 3, 4, and 5).

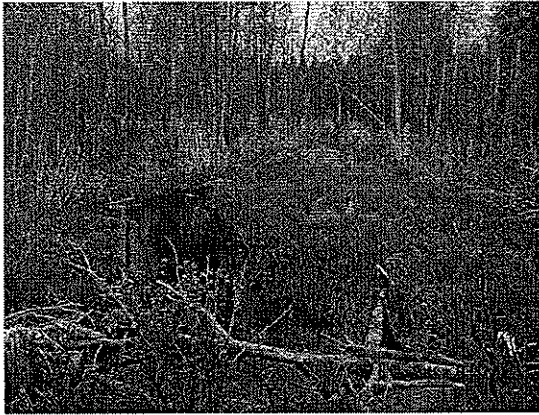
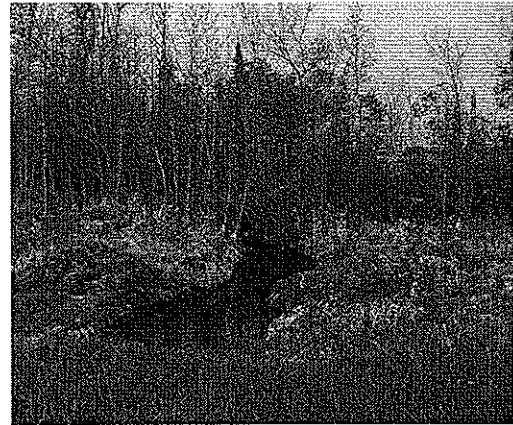
Figure 12 – Bostick Creek Watershed is Stable

In 2005, the Bostick Creek watershed appears to be reasonably “in balance” with respect to overall watershed sediment yield. A tour of the watershed revealed no obvious large-scale erosion problems. Generally, the land, road ditches (except JD 28), and stream banks are well vegetated and stable. Total suspended solids (TSS) readings provided by the Soil and Water Conservation District also indicate acceptable readings in Bostick Creek with the exception of extreme runoff events. The universal soil loss equation indicates that the average annual sediment for the watershed is 0.13 tons/acre/year, where an acceptable level approaches a vastly larger 3.0 tons/acre/year. Clearly, based upon current land use and soils, the Bostick Creek watershed sediment yield is low, acceptable, and not a significant source of sediment causing problems downstream (Figures 12, 13, 14, and 15).

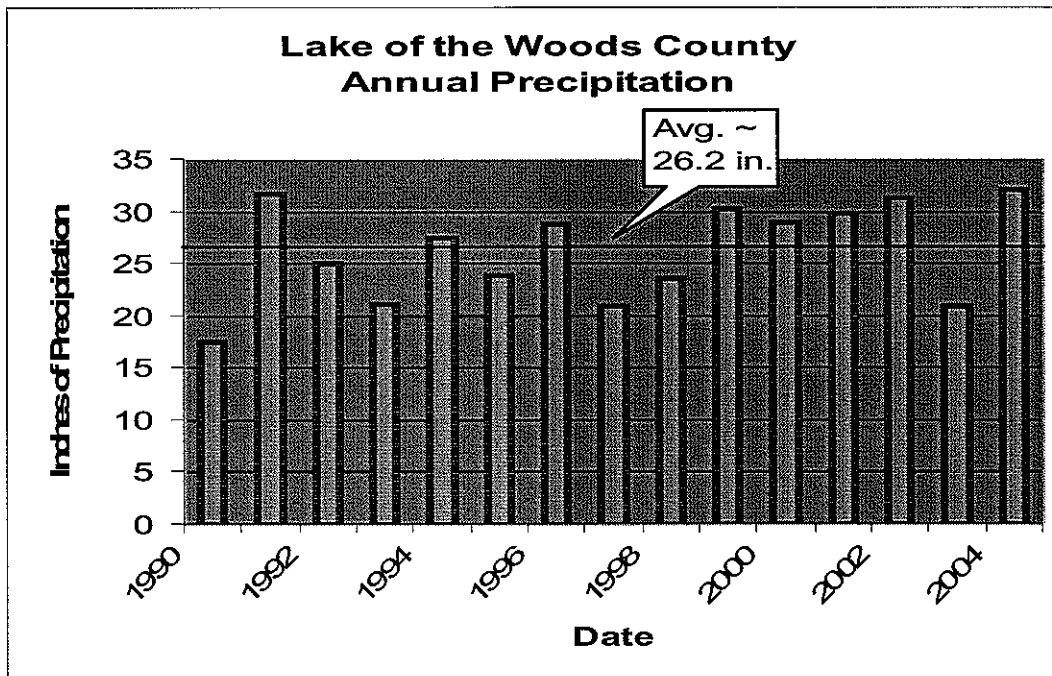
Figure 17 – Recent Precipitation, Note Upward Trend. 5/6 Years Above Average Since 1999

Between June 9-11, 2002, Lake of the Woods County experienced between 10 – 18 inches of rainfall. According to anecdotal accounts, County Road 4 (which parallels JD 28) was overtopped. JD 28 was severely undermined and eroded a significant amount. Nearer Bostick Bay, large areas of streambank and other channel material near the County Road 8 bridge was relocated out into Bostick Bay, essentially filling in traditional navigational channels. TSS levels were understandably high during this extreme runoff event. Natural disasters such as this event are rare and tend to skew long-term trends. However, this event substantially affected JD 28 and Bostick Bay such that this investigation was initiated to address navigational issues on Bostick Bay and future actions required to maintain an acceptable sediment balance in the watershed (Figures 16, 17, and 18).

Status: Flooding of homes downstream of JD 28 did not occur during the extreme June 2002 event, but was imminent. However, roads, outbuildings, farmlands, and pasture lands were significantly flooded. There is also the perception that flooding has been becoming increasingly common when compared to unsubstantiated historical accounts along Bostick Creek. This perception likely has merit upon review of short-term hydrological records shown in Figure 17. Over a period of 15 years of precipitation, the last 5 of 6 years have been over the 15-year average of 26.2 inches. Over a period of record of 75 years, the average precipitation has been 22 inches per year. There has been a steady rise in recorded annual precipitation over that time, exemplified by the more recent 15-year average and recent years of precipitation in the 30 inch plus range.

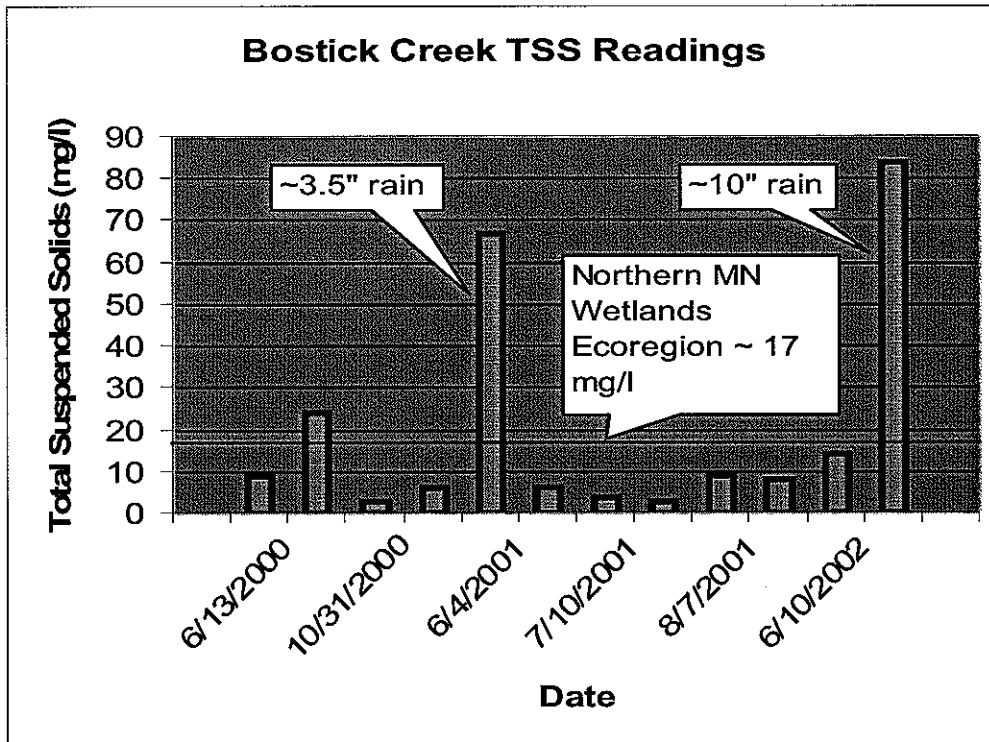
Figure 18 – LOW SWCD Total Suspended Solids Measurements
