Geology Report

Project: Bostic Creek Jurisdictional Ditch 16 / Jurisdictional Ditch 28 Stabilization Project.

Location: Lake of the Woods County, MN

Date of investigation: September 3, 2013

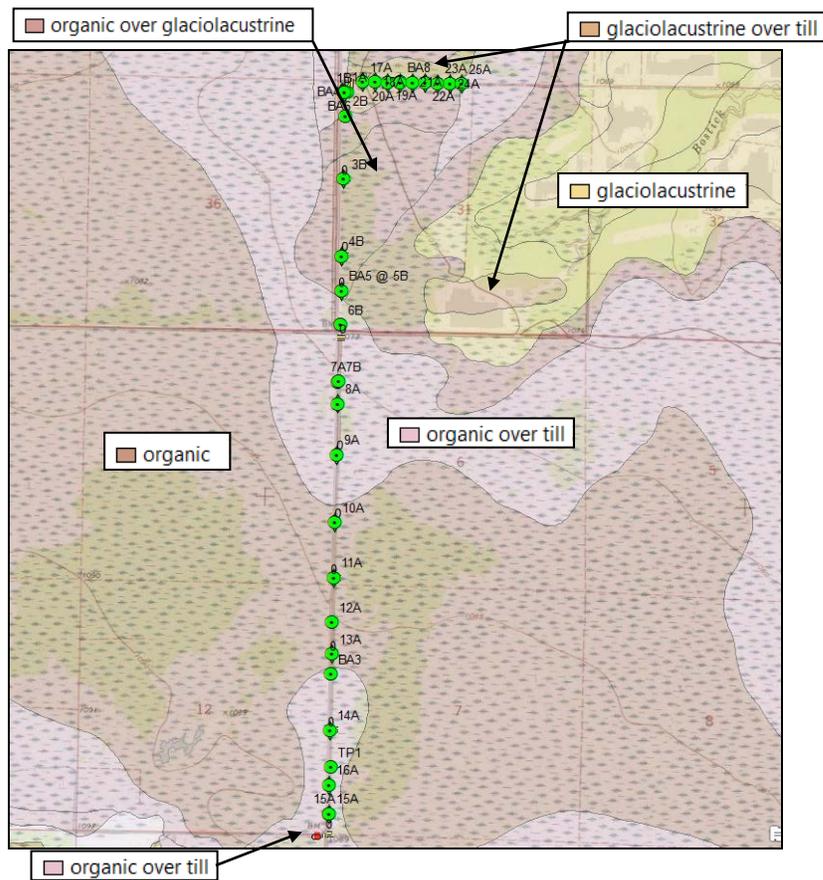
Figure 3- Soils parent material map of the portion of the JD-16/JD-28 ditch that we are currently focusing on for this report.

sorted coarse grained sediment in outwash plains. These glacial rivers were occasionally blocked to form meltwater lakes like Glacial Lake Benson and Glacial Lake Agassiz in front of the retreating glacier. As mentioned in the introduction, the sediment deposits in the watershed have been modified by Glacial Lake Agassiz. After the glaciers retreated there has been 7,000-10,000 years of erosion occurring on the landscape which further moved and re-deposited sediment as colluvium and alluvium. This created the pre-ditch stream network. Because of the complex geologic history described above, the soil parent material on the site is a mix of interlayered glacial till, sandy near shore lacustrine deposits, clayey lacustrine deposits, and highly organic soils formed in historical low spots in the landscape (figure 3).

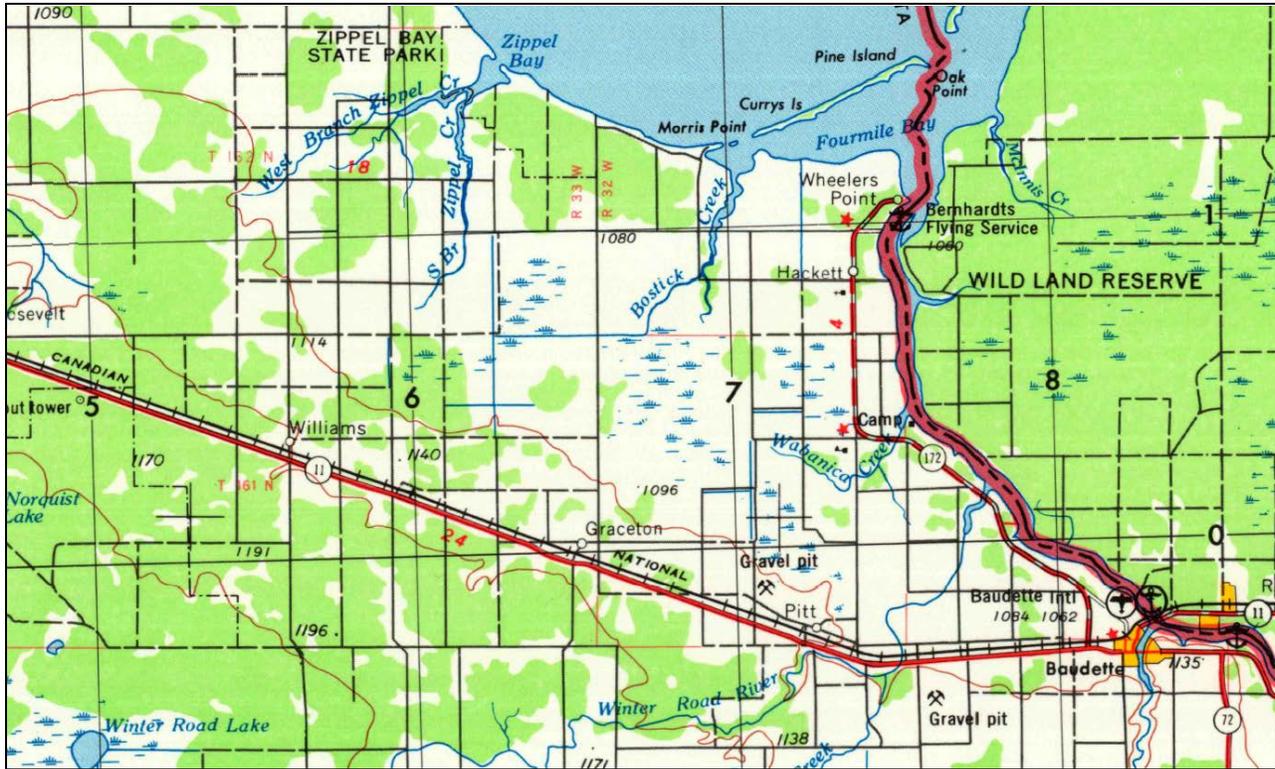
Figure 4- Historic USGS Topographical map of project area made in 1954. This was made prior to the construction of the JD-16/JD-28 ditch. A majority of the Bostick/Zippel watersheds are covered by wetlands and flat topography with steeper beach ridge on the south-western edge of the watersheds.

to the area. Historic topography maps from 1954 show a lot of poorly drained areas that are more conducive to groundwater recharge instead of surface runoff and drainage (figure 4).

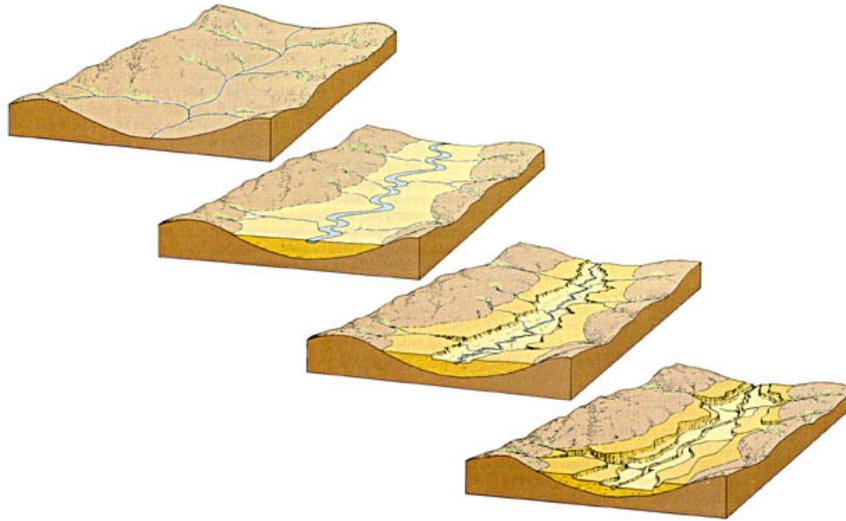
Figure 5- Simplified example of landscape evolution. As the larger river matures over time, it erodes and causes additional down cutting and erosion in the smaller tributaries as they adjust to the change in grade. This process steepens the watershed and increases the runoff from the upland.

Over a long period of time the drainage network will naturally developed in the best places to drain the landscape. Figure 5 shows a simplified example of landscape evolution through time. In this example, the landscape is steepened and eroded by head ward erosion from the bottom of the watershed upward to compensate for a change in the base level of the stream outlet. As it is steepened rills and gullies continue to work their way up into the upland. The 1954 topographic map of the site (Figure 4) shows that this same process may have started in all of the natural draws on the edge of Lake of the Woods after the glaciers and Glacial Lake Agassiz had receded. The base level of Bostick Creek is being controlled by variations in water level at the dam on the north end of Lake of the Woods. So as long as the dam on the northern edge of Lake of the Woods is in place Bostick creek will not evolve to the level shown in figure 5. But it will see some adjustments due to anthropogenic changes in lake water level, watershed drainage area, and the drainage ditch systems.

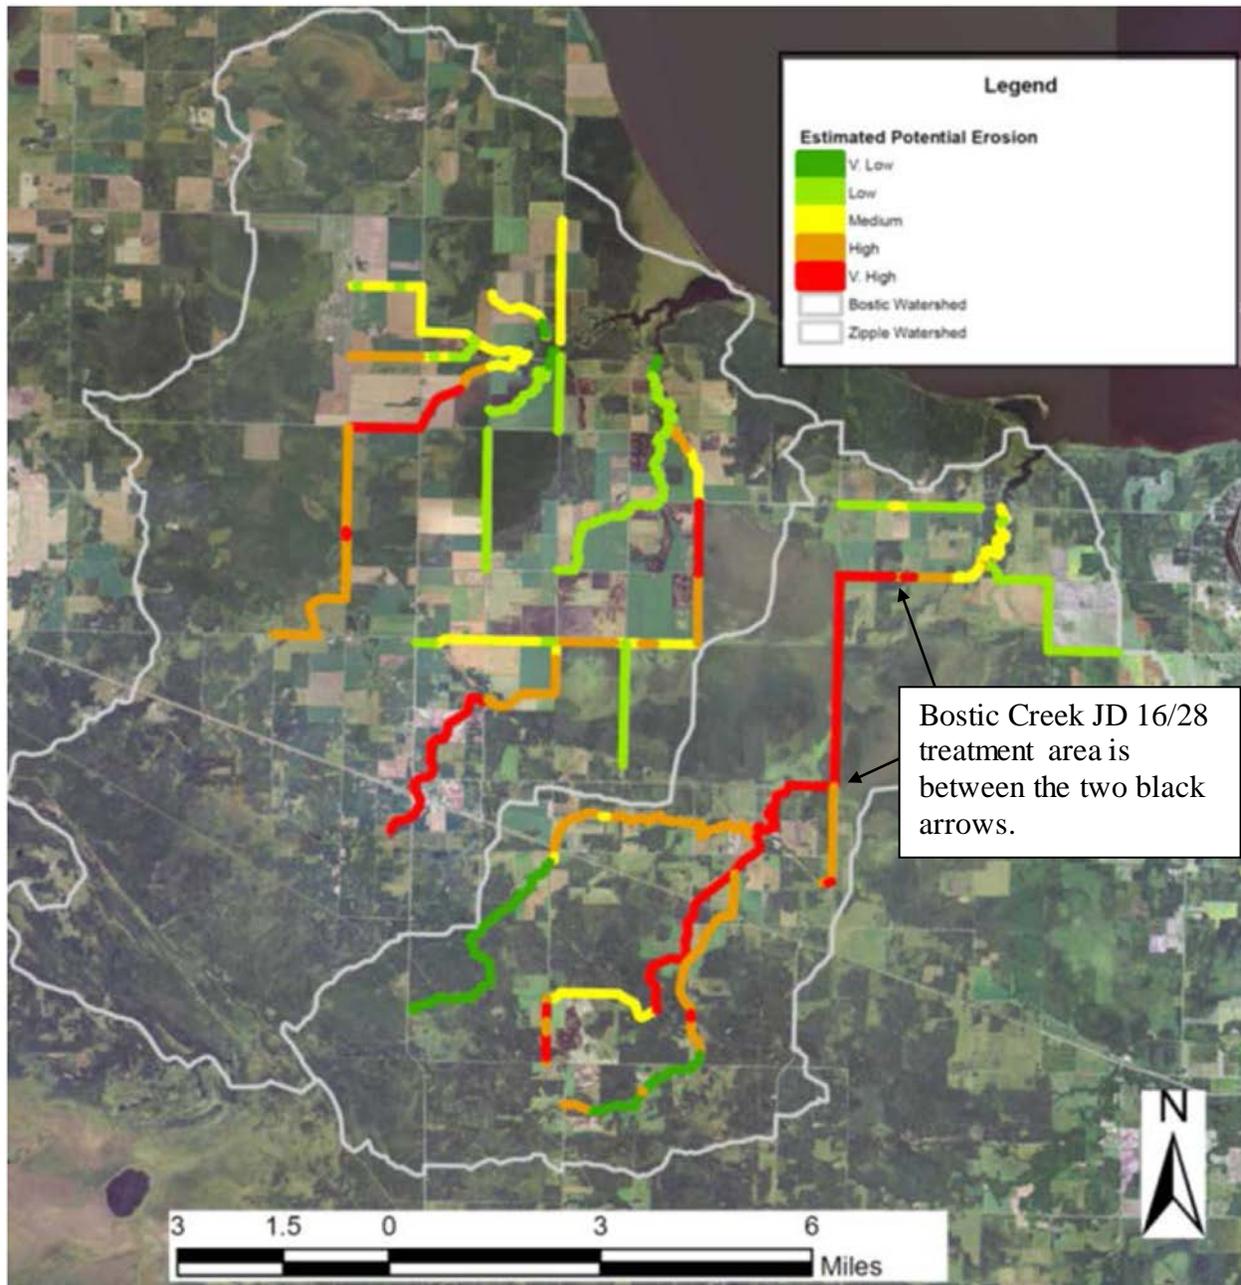
Figure 6 – Map of estimated potential erosion in the Bostic / Zipple watersheds. Bostic Creek JD-16/JD28 treatment area is between the two black arrows.

During the Bostic / Zipple watershed analysis, a stream power GIS layer was overlain with a sediment erosion potential GIS layer to create a layer which estimates potential erosion in the watersheds. Based on this analysis the JD-16/JD-28 portion of the watershed has a very high potential for erosion. This makes it a good area to target to reduce sedimentation to the Lake of the Woods.

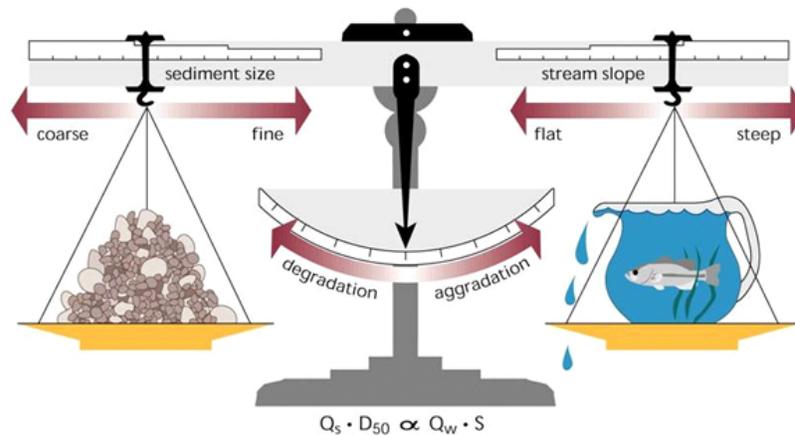
Figure 7- Lane's Balance.

for any given location in a stream system (figure 7). The water flow properties such as slope and the Discharge (Q) of water are on the right hand side of the balance. The Discharge equals the cross sectional area of the stream at a given flow times the velocity. A given rainfall event in the watershed will create a certain discharge. As the cross sectional area decreases and the stream is restricted like it is in a constructed ditch the velocity will increase creating erosion. Sediment transport properties such as sediment size and the amount of sediment being transported are on the left hand side. Increase in flow velocity can cause increased erosion upstream which can cause an increase in the sediment load.

As you increase the amount of water, decrease the cross sectional area, or the slope of the stream the balance tips to the right and you have more degradation or erosion in the stream. As you increase the amount and size of sediment being transported in the stream beyond what the stream can transport the sediment is deposited. Using a general understanding of Lane's Balance and our understanding of the changes in the watershed you would predict an overall increase in degradation in the watershed. Our investigation of the JD-16 portion of the Bostic creek ditch system verifies this. It seemed like erosion is more common than deposition in all parts of the ditch system we walked except the outlet into the Lake of the Woods where the slope gets very flat.

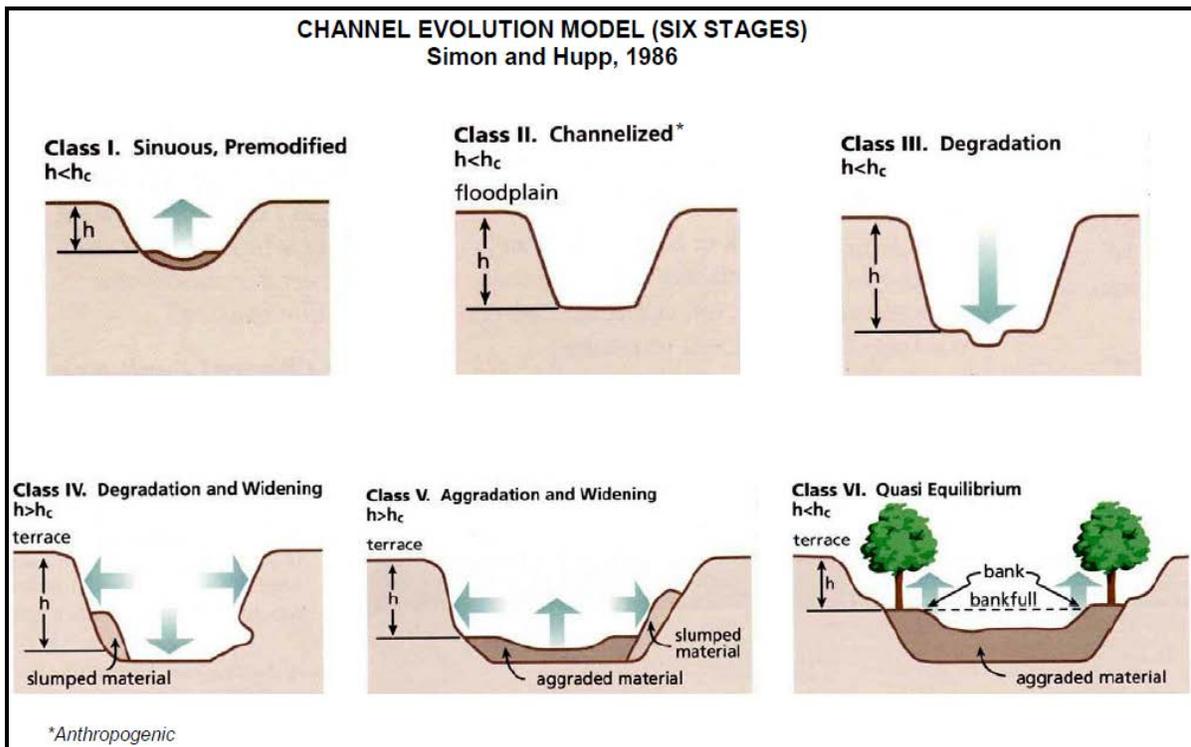
Figure 8- Cross Sectional view of the Channel Evolution Model (Modified from Simon and Hupp, 1986).

Another useful means of analyzing a stream is with Simon's Channel Evolution Model (figures 8 and 9). This model takes the concepts of aggradation and degradation one step further and applies it to how a stream system adjusts after a disturbance event that increases the water flow side of the lanes balance equation. As shown in figure 9, the Simon stages usually vary across the longitudinal profile. Stage I is the pre-modified condition (pre-ditch). Stage II is the modified condition (creation of the ditch). Stage III is degradation otherwise known as down cutting of the channel. Typically the degradation occurs as a gully head (also known as a knickpoint) is moving upstream setting a less steep grade of the streams' longitudinal profile. The gully head (also known as a knickpoint) continues to degrade and begins to widen. Stage IV begins to occur as degradation and widening of the channel creates an unstable side slope. The gully moves upstream until a stable profile is reached. The downstream areas begin to aggrade and fill

in as the channel widens enough to start reducing the stream power allowing increases in deposition. Stage V begins to occur as aggradation and widening creates a large sediment load which begins to outweigh the strength of the flow. This typically happens in the lower portion of the watershed when the slope of the stream becomes less steep and the cross section has widened the most. Stage VI is a temporarily stable point known as the Quasi Equilibrium. This typically occurs when a stream has established an equilibrium with the environment. This is commonly achieved in a stream that is well connected to the floodplain, allowing the cross sectional area to widen and create lower velocities during large rain events which cause high discharges.

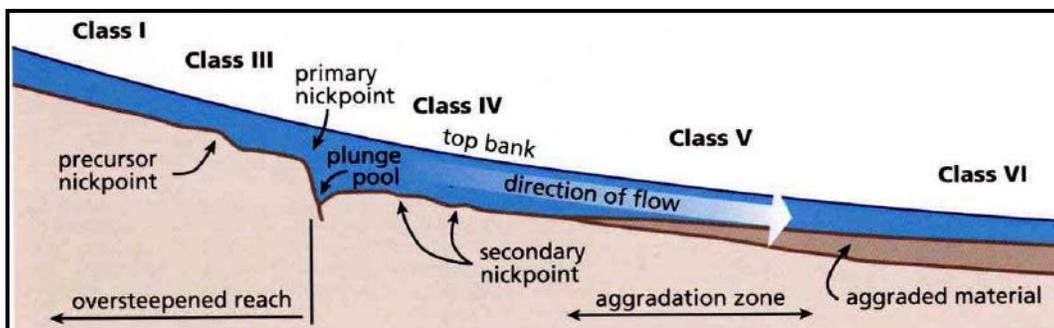
Figure 9 – Profile view of the Channel Evolution Model (Modified from Simon and Huopp, 1986).

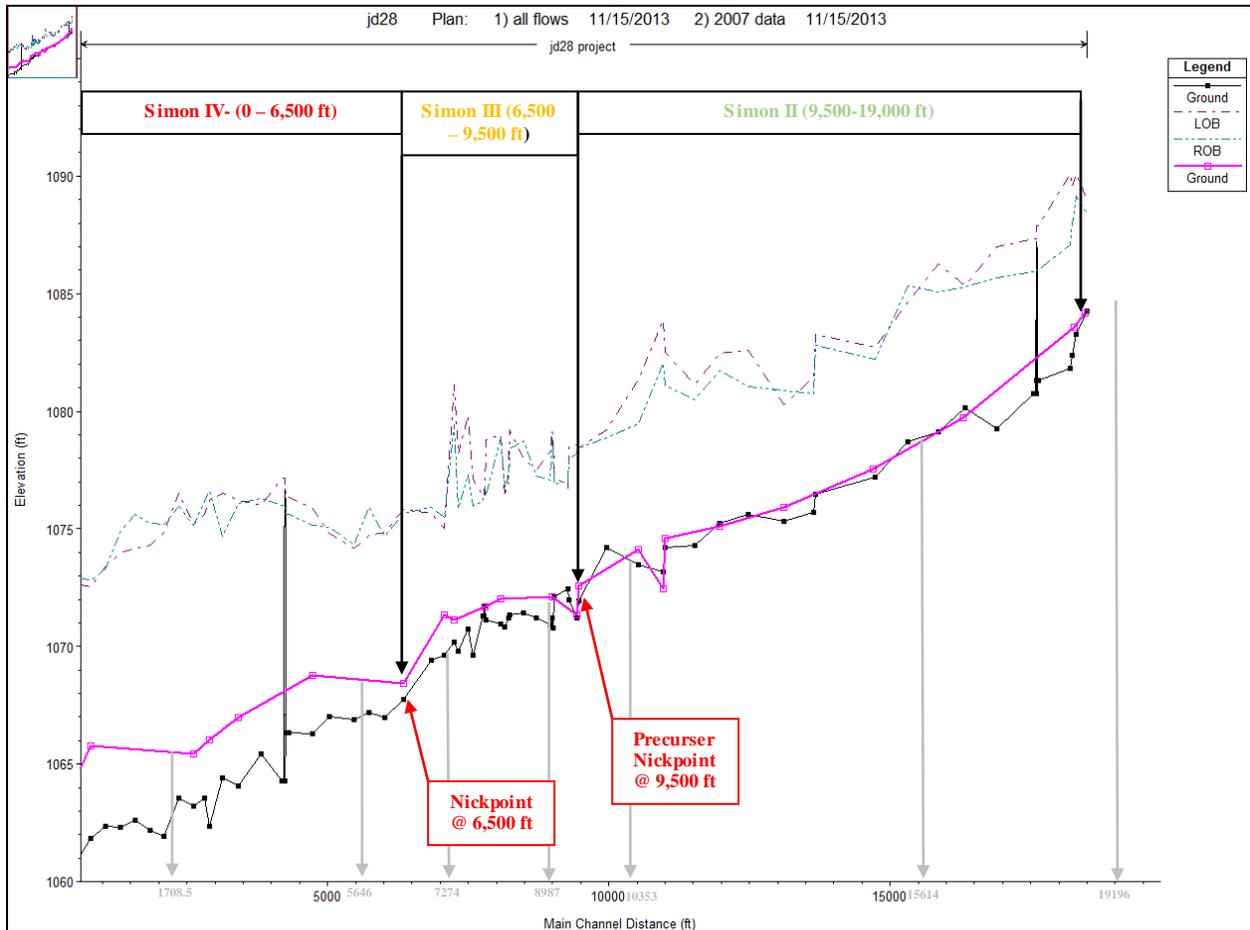
Figure 10- Surveied profile showing the survey from 2013 in black and the survey from 2007 in pink. The reach is subdivided based on the interpreted Simon CEM classification. Two interpreted nick points have been identified in red. The locations of cross sections discussed later in the text are shown in gray.

Figure 10 is a surveyed profile showing the estimated Simon Channel Evolution Model classifications determined based on our walks across the site and while looking at the survey profile and cross section data. Two potential knick points (also known as gullies)

have been identified on the profile which indicate current and likely future degradation in that portion of the ditch system.

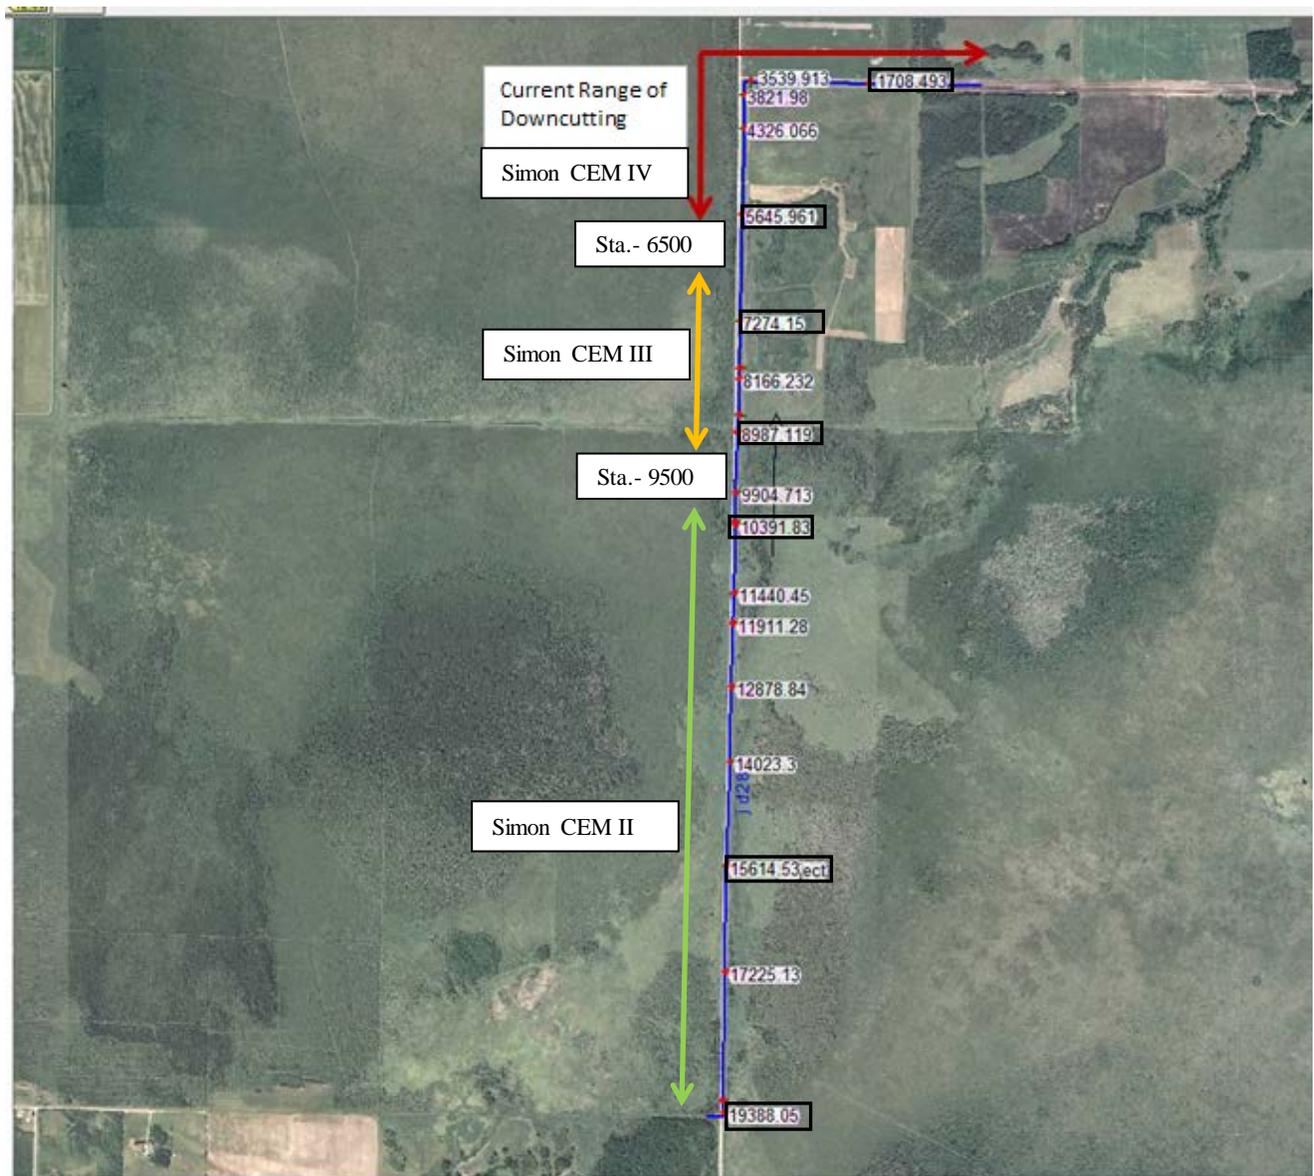
Figure 11 – Map of the EQIP application area showing the currently assumed Simon Channel Evolution Model (CEM) classification based on the information viewed in the field. The locations of cross sections discussed later in the text are shown in the black rectangle

Figure 11 depicts the interpreted Simon CEM classification shown in figure 10 on a plan view map. The locations of the representative cross sections discussed later in the text have a black rectangle around them. The rest of this section of the report will use the representative cross sections to explain the Simon CEM classifications portrayed in figures 10 and 11. It is recommended that the reader cross references these figures while reading the rest of the text in this section.

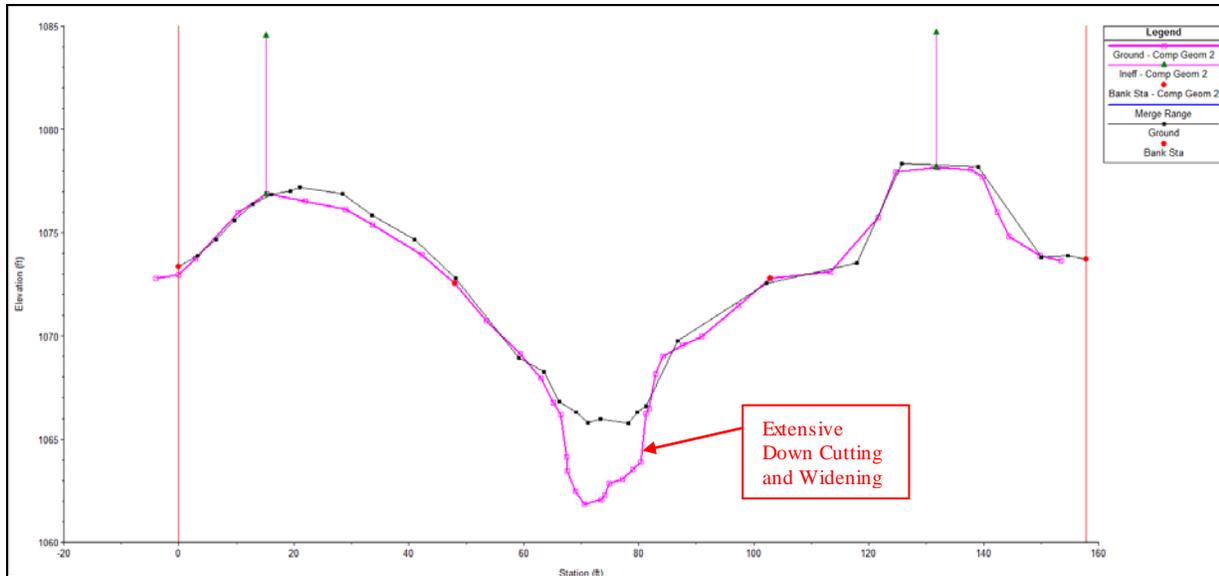
Figure 12- Typical cross section of the reach from 0-6500 ft taken at station 1708.5. Showing the survey in 2007 in black and 2013 in pink. Areas of extensive erosion are labeled in red.

As seen in the typical cross sections for the reach between station 0-6500 (figure 12 & 13), I believe this stretch is experiencing fairly significant adjustment by down cutting and widening associated with increased flow in the watershed or changes in the base level of the Lake. I believe this process is part of a watershed wide degradation process started by anthropogenic changes in the watershed / ditch system and / or changes in water level of Lake of the Woods creating changes in the base level of the stream. This stretch appears to be very unstable and has likely degraded a lot in the past (Simon CEM stage IV). The hydrology needs to be analyzed but I assume there is too much discharge for the size, shape, and slope of the channel. If this is the case, degradation and widening associated with increased flow in the watershed will continue and likely migrate upstream.

Stabilization attempts should include grade control and adjustment of ditch cross sectional area to create a meandering two stage ditch system.

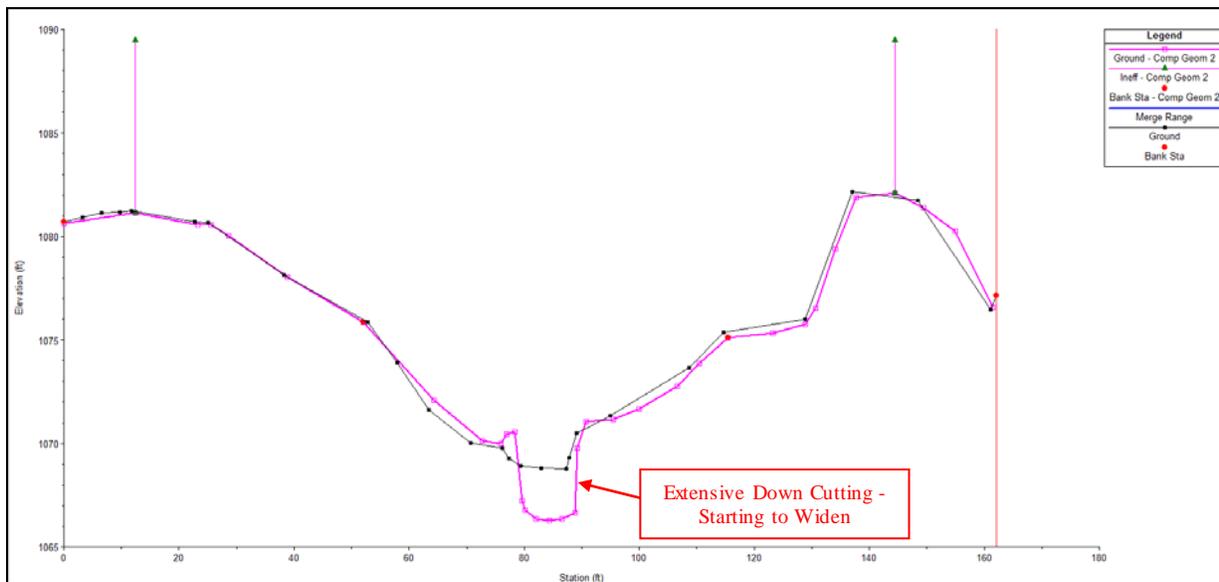
Figure 13- Typical cross section of the reach from 0-6500 ft taken at station 5646 ft. Showing the survey in 2007 in black and 2013 in pink. Areas of extensive erosion are labeled in red.

I believe this stretch will continue to degrade until a stable grade is reached the reach will then continue to widen until the angle of repose is reached for the material on the banks of the channel. I believe future widening of this ditch section will be exasperated by variable geologic conditions present on the ditch banks of this reach. This will be discussed in more detail later in the geotechnical portion of the report.

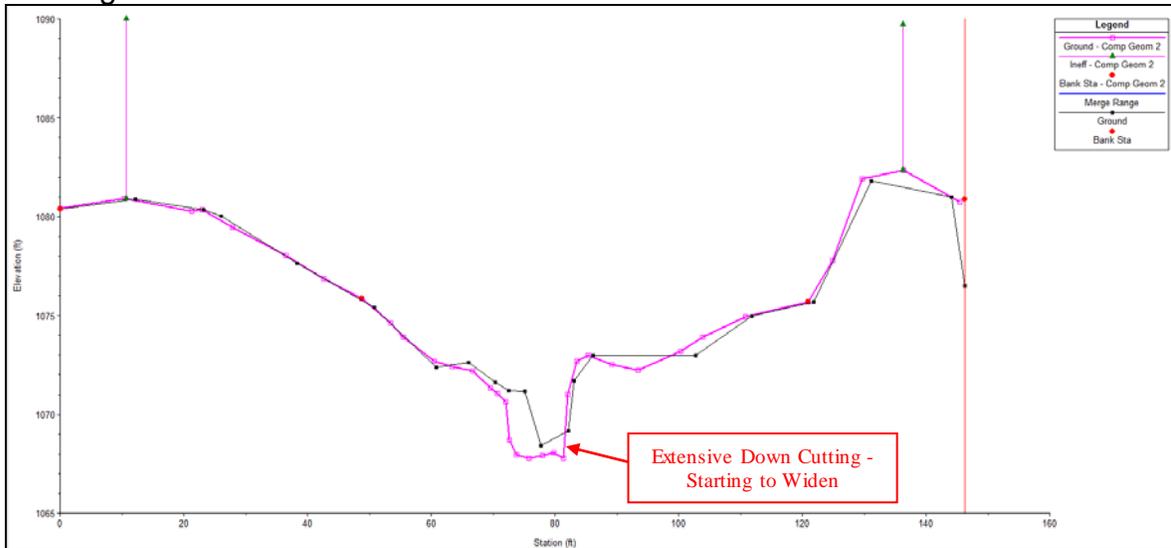
Figure 14- Typical cross section of the reach from 6500-9500 ft taken at station 7274 ft. Showing the survey in 2007 in black and 2013 in pink. Areas of extensive erosion are labeled in red.

As seen in the typical cross sections for the reach between station 6500-9500 (figure 14 and figure 15), this reach appear to be very unstable and has likely been down cutting a lot in the past (Simon CEM stage III). The hydrology needs to be analyzed but I assume there is too much discharge for the size, shape, and slope of the channel. If this is this case degradation and widening associated with increased flow in the watershed will continue creating a Simon CEM stage IV reach. Stabilization attempts should include grade control and widening of the ditch to create a meandering two stage ditch as shown in red on figures 14 and 15.

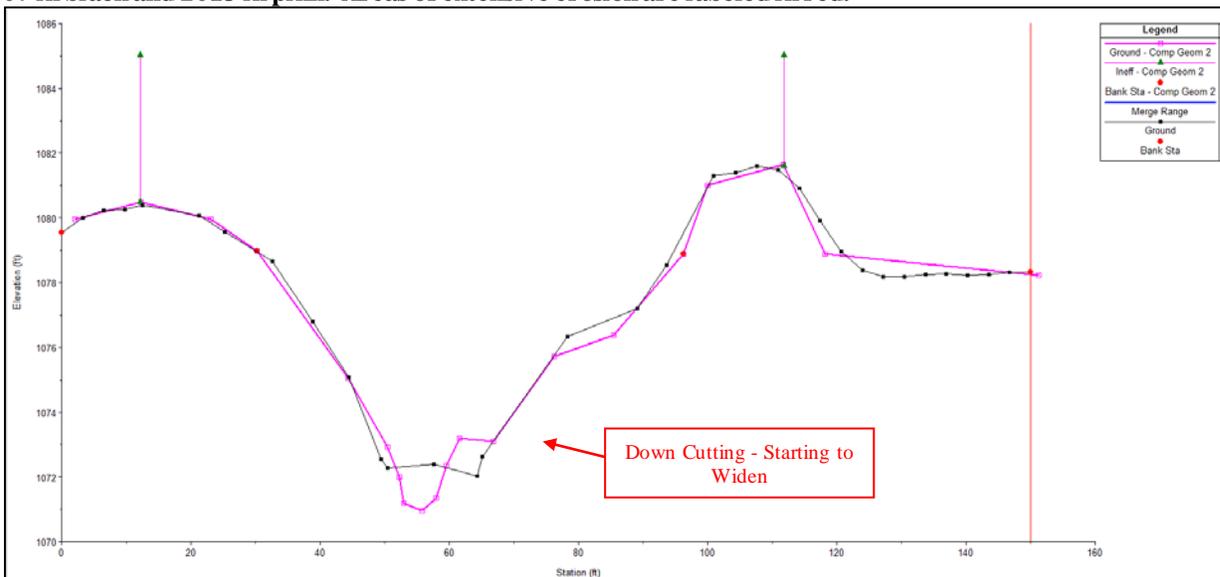
Figure 15- Typical cross section of the reach from 6500-9500 ft taken at station 8987 ft. Showing the survey in 2007 in black and 2013 in pink. Areas of extensive erosion are labeled in red.

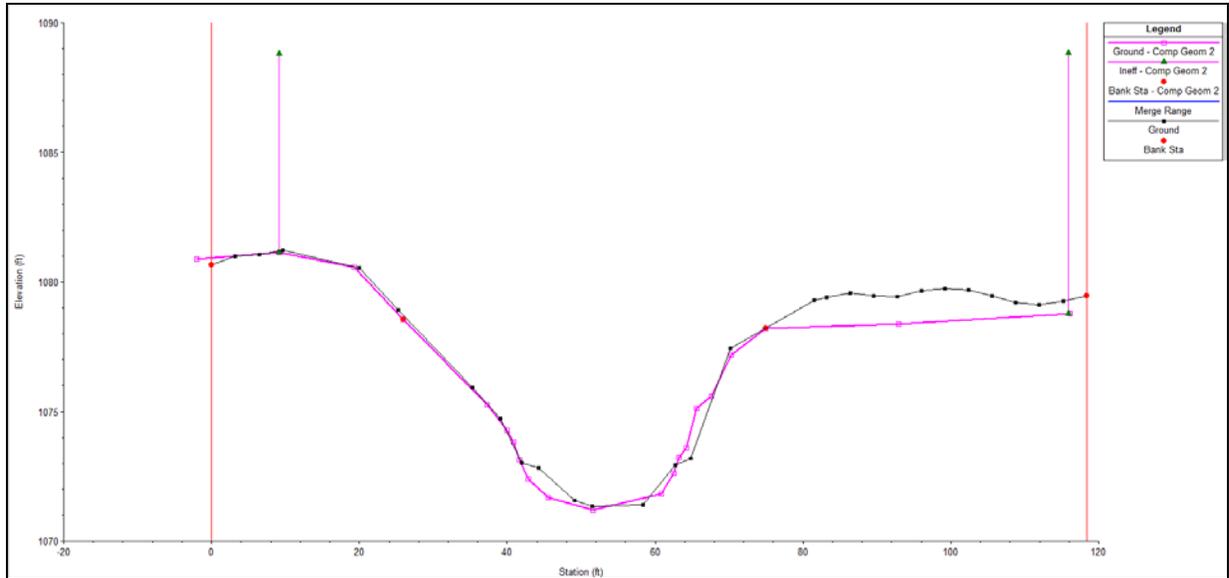
Figure 16 - Typical cross section of the reach from 9500-19388 ft taken at station 10353 ft. Showing the survey in 2007 in black and 2013 in pink. This reach appears to be stable.

As seen in the typical cross sections for the reach between station 9500-19388 (figure 16 - 19), although there are places with localized stream bank erosion this reach appear to be stable (Simon CEM stage II). But if left unprotected by grade control on the lower portions of this reach I believe the gully will continue to work up from downstream and destabilize

this portion of the stream eventually. In my opinion a new stable longitudinal profile grade needs to be established using some type of grade control. A stable cross-sectional area and grade will need to be estimated using the hydrology of the site.

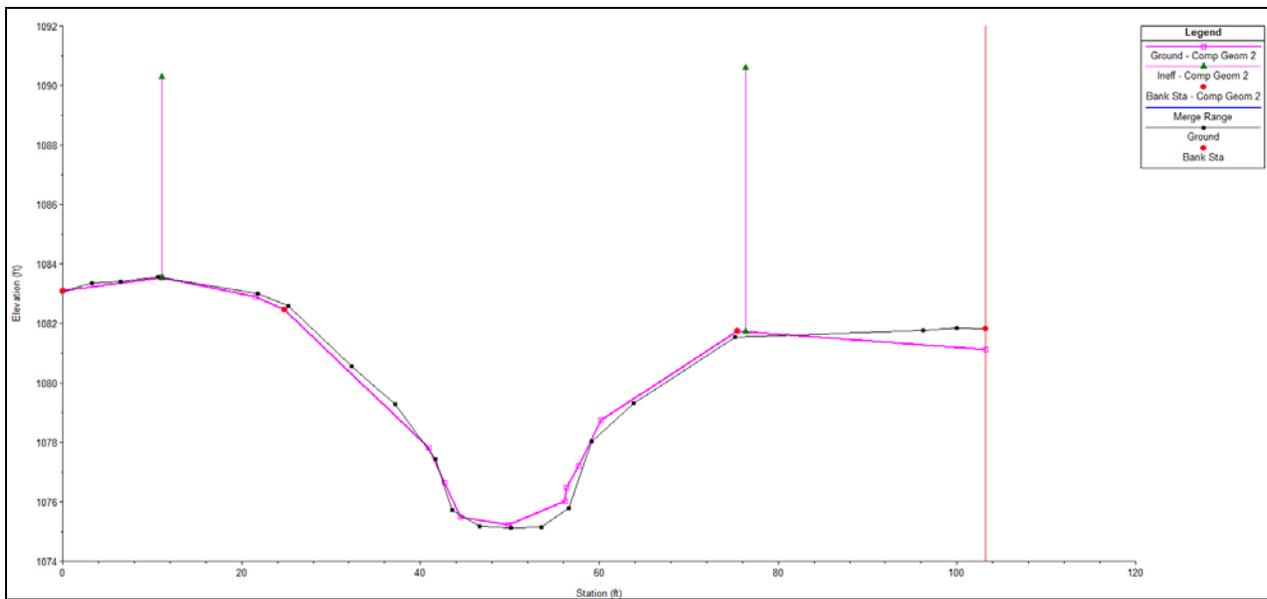
Figure 17 - Typical cross section of the reach from 9500-19388 ft taken at station 10353 ft. Showing the survey in 2007 in black and 2013 in pink. This reach appears to be stable.

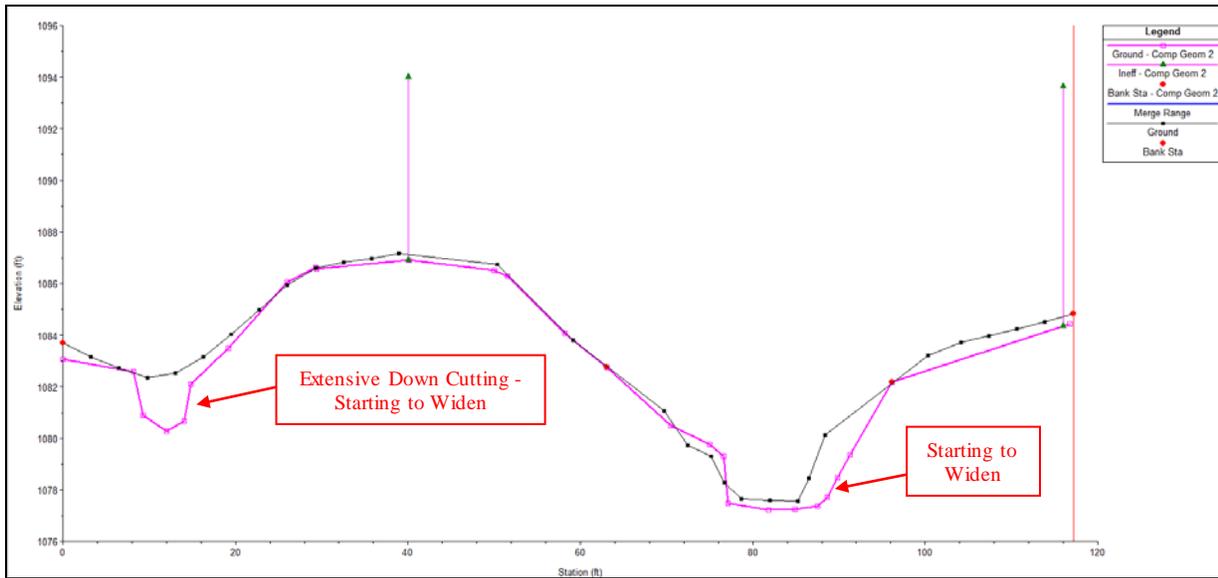
Figure 18 - Typical cross section of the reach from 9500-19388 ft taken at station 15614 ft. Showing the survey in 2007 in black and 2013 in pink. Areas of extensive localized erosion are labeled in red. But overall the reach is stable.

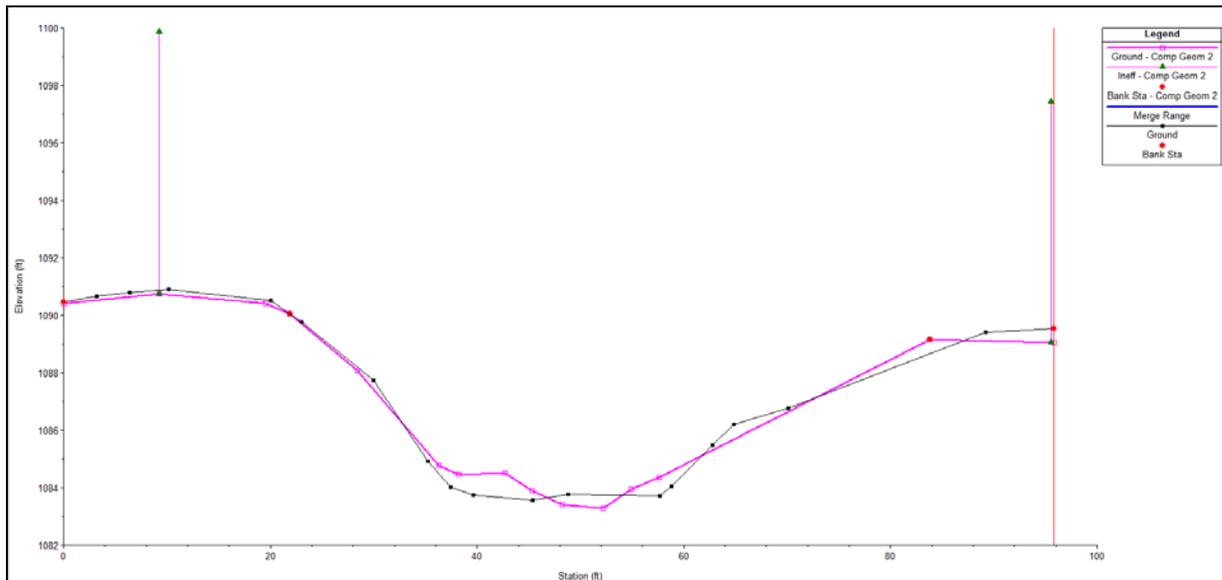
Figure 19 – Typical cross section of the reach from 9500-19388 ft taken at station 19196 ft. Showing the survey in 2007 in black and 2013 in pink. This reach appears to be fairly stable.

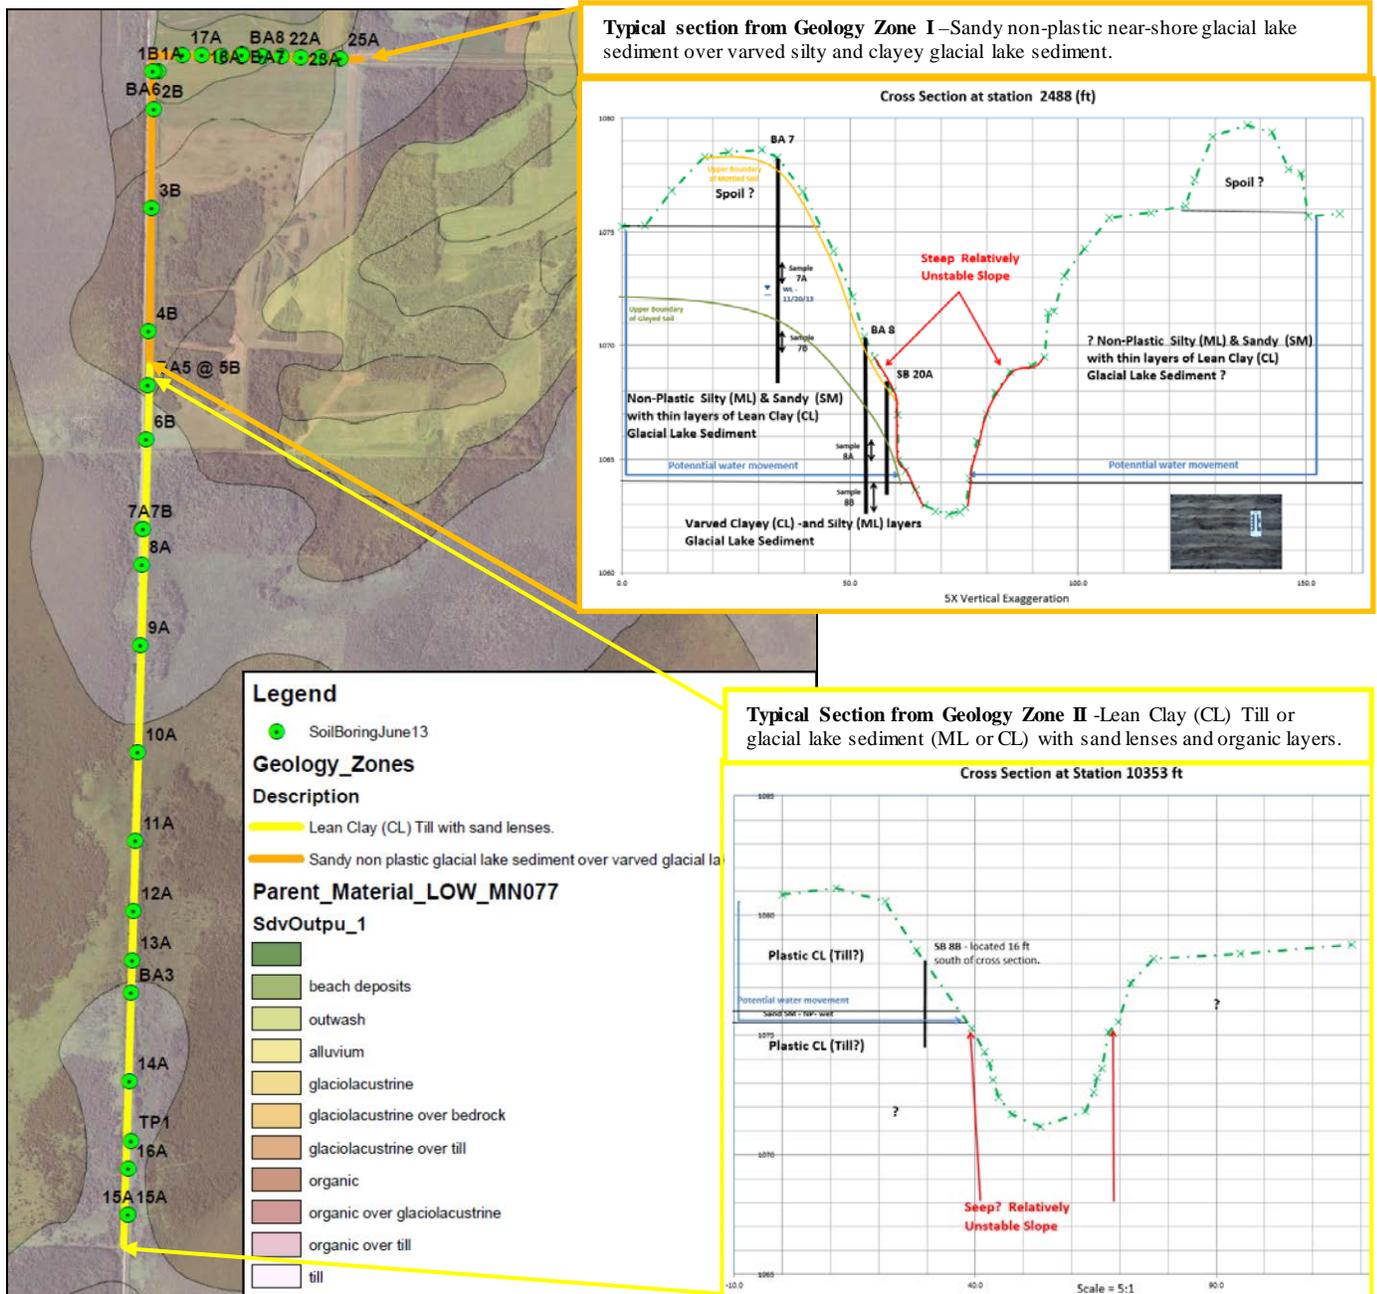
Figure 20- Map of studied reach divided into two geology zones based on the results of the geologic investigation.

As seen in figure 20 and 21; Geology Zone 1 goes from station 0 to around station 7500. As seen in the typical cross section at station 2488 (figure 20, figure 21, Appendix B, and Appendix C), this area is comprised of non-plastic sandy or silty near-shore glacial lake

As seen in figure 20 and 21; Geology Zone 2 goes from station 7500 to around station 18000. As seen in the typical cross section at station 10353 (figure 20, figure 21, Appendix B, and Appendix C), this area is comprised of plastic Lean Clay (CL) or Silty

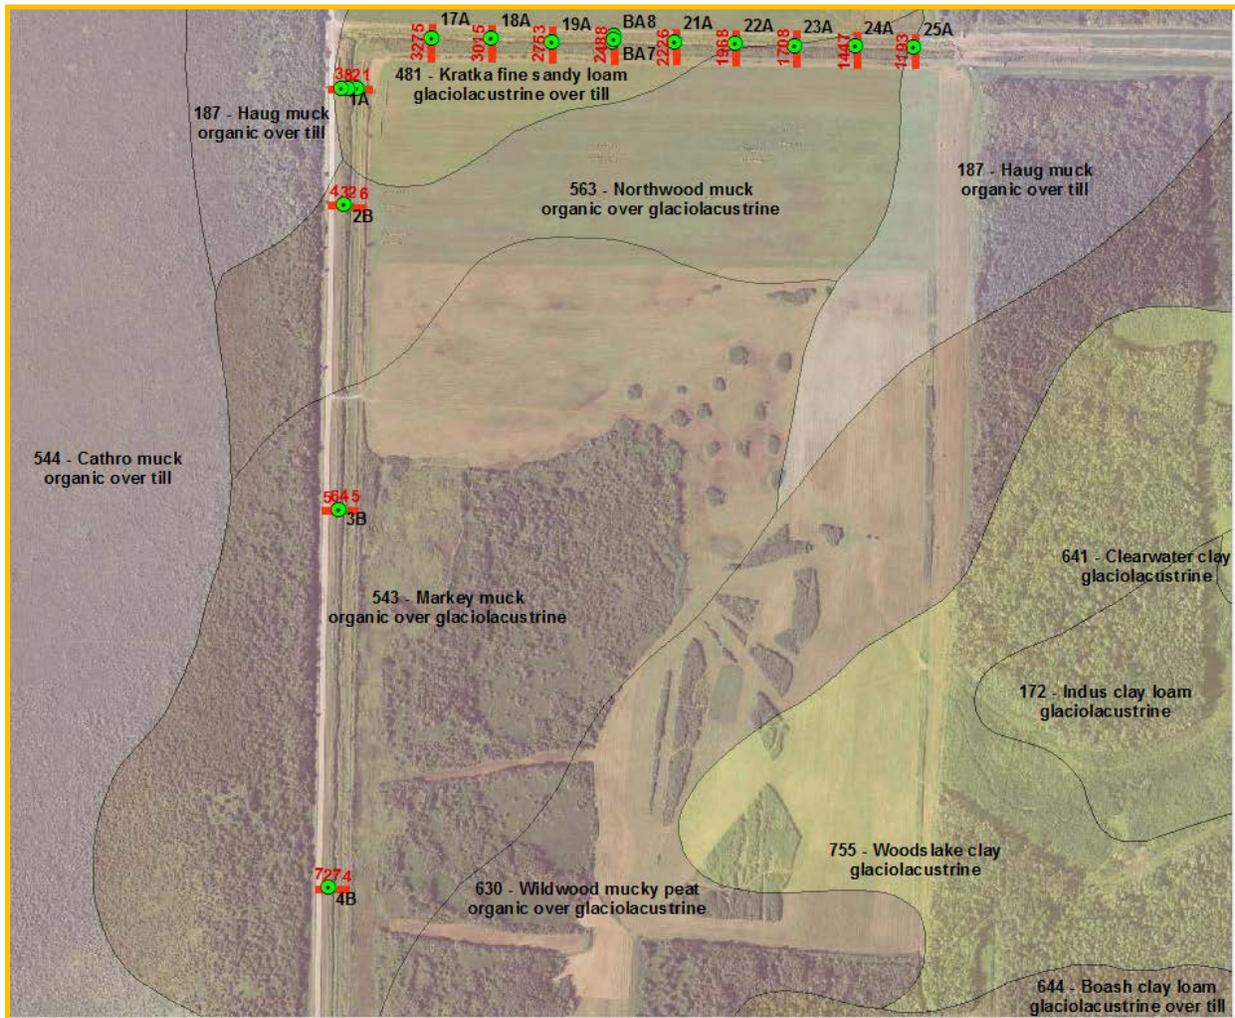
Figure 21- Map showing the SURGO soil with parent materials, the cross sections in red, and soil borings in green within “Geology Group I”. The cross-sections in this portion of the area all resemble the Geology Group I Typical cross section from station 2488 as seen in figure 20. Most of the cross sections in this group showed a similar pattern of non-plastic sandy or silty near-shore glacial lake deposits over clayey and silty varved off-shore glacial lake deposits (Appendix C).

deposits (SM and ML) over clayey and silty varved off-shore glacial lake deposits (ML layered with CL-CH). This variable geology creates a high potential for seepage at the intersection between the near-shore and off-shore glacial lake sediments. The horizontal layers of clay within the varved off-shore deposits forces water to move laterally creating the potential of increased seepage on the upper edge of the off-shore deposits as noted on the cross sections. The other disadvantage of the geology on this zone is the low structural strength associated with the ML portion of horizontally layered varved off-shore glacial lake sediments. As a result, the bottom of the stream in this geology zone is a lot more prone to down cutting and erosion than it initially appeared.

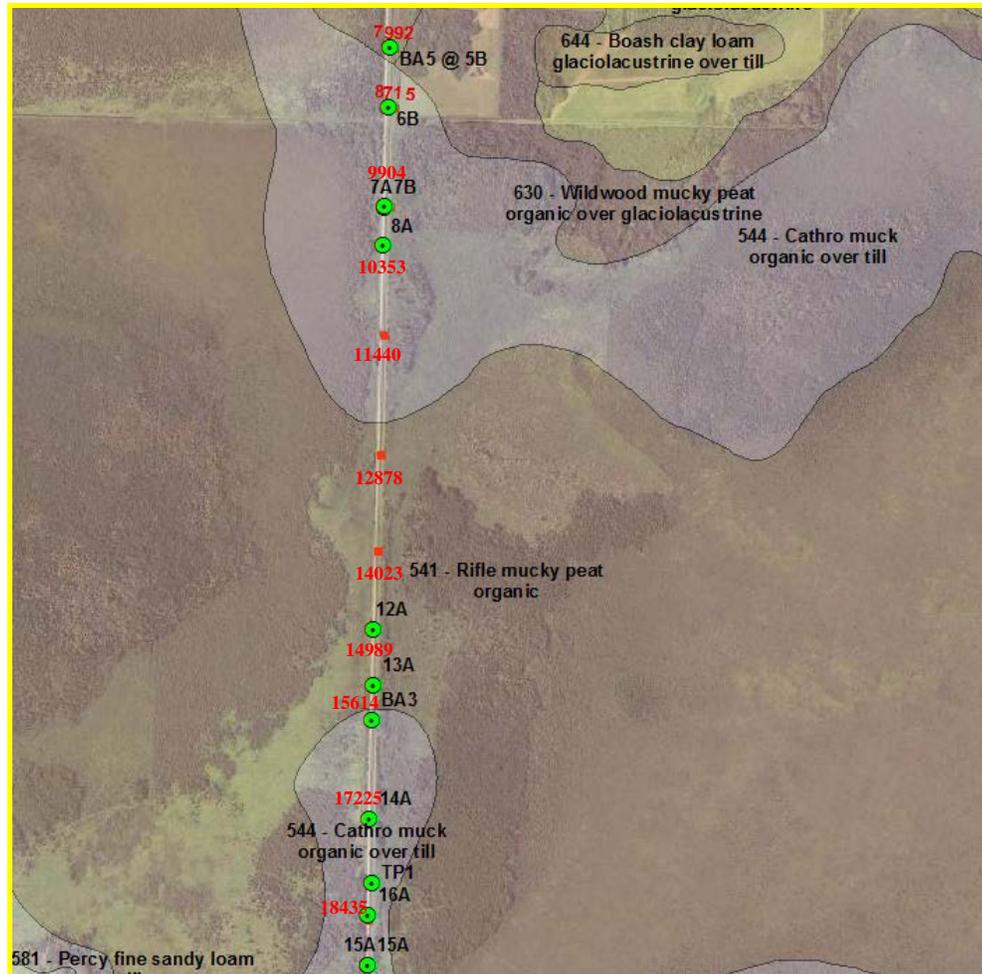
Figure 22- Map showing the SURGO soil with parent materials, the cross sections in red, and soil borings in green within “Geology Group II”. The cross-sections in this portion of the area all resemble the Geology Group II typical cross section from station 10353 as seen in figure 20. Most of the cross sections in this group showed a similar pattern of plastic Lean Clay (CL) or silty (ML) sediment either deposited as glacial till or glacial lake sediment with small (<1 ft) sand layers and / or organic layers identified in some of the cross sections (Appendix C).

(ML) sediment either deposited as glacial till or glacial lake sediment with small (<1 ft) sand layers and / or organic layers identified in some of the cross sections (Appendix C).
