Bostic & Zippel Creeks Watershed Assessment

Lake of the Woods County, Minnesota

January, 2013

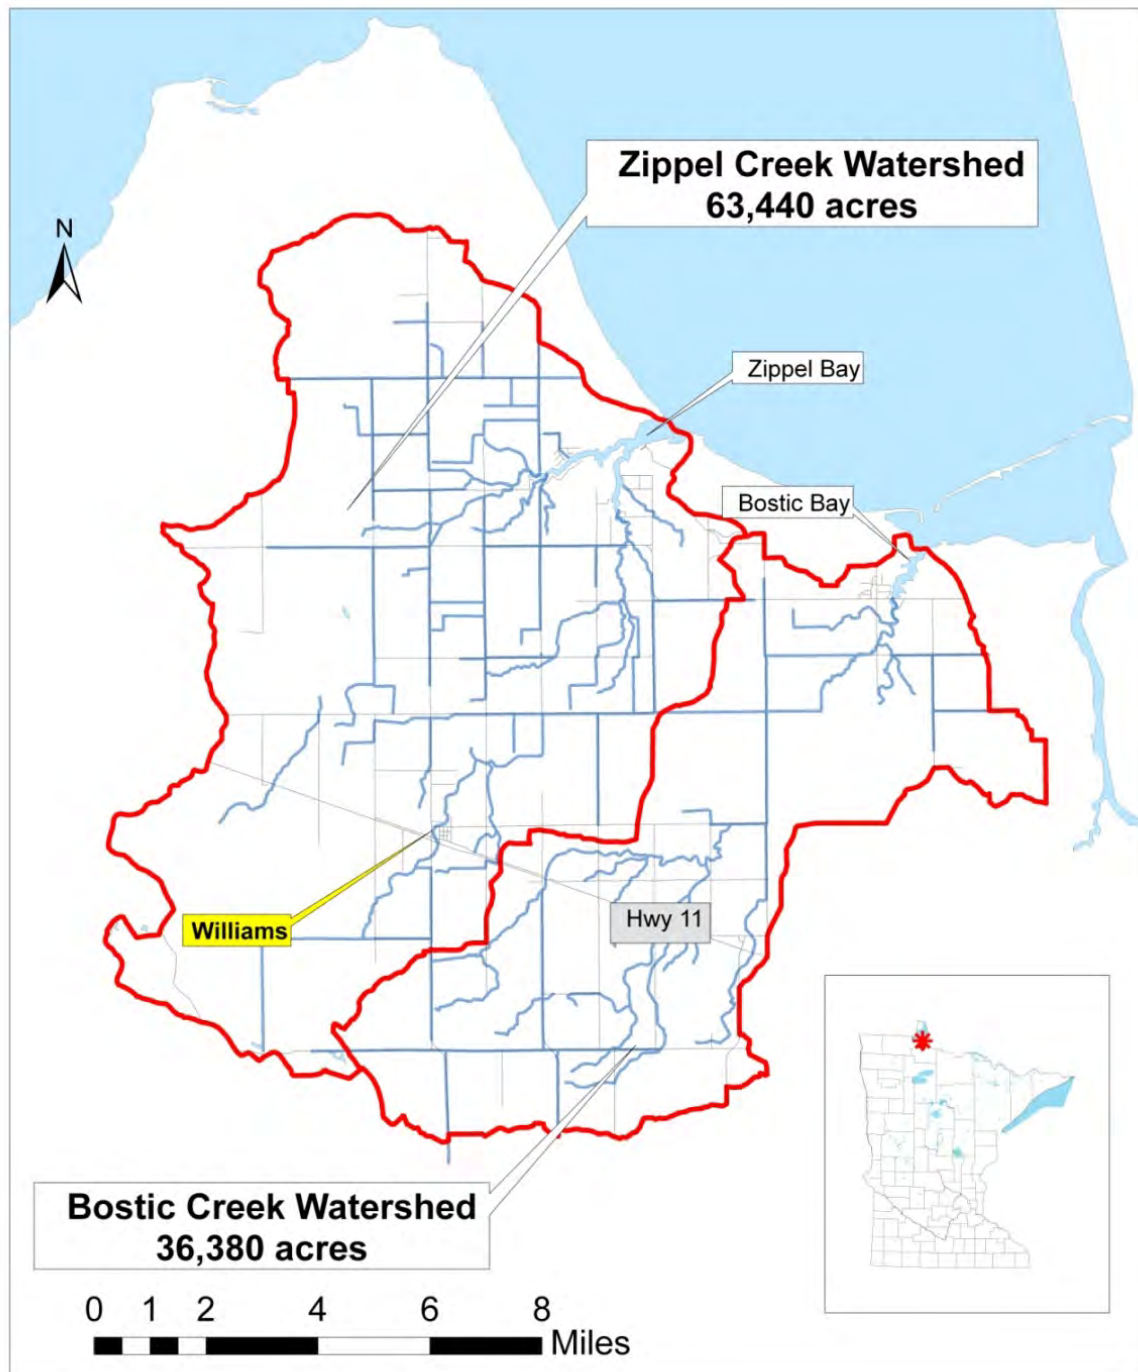
Figure 1 - Project Map

Bostic and Zippel watersheds are located in Lake of the Woods County and are 36,380 acres and 63,440 acres in size respectively. See Figure 1. The watersheds are approximately 15 miles northwest of the county seat of Baudette, population 1,106 (2010 census). Both watersheds drain in a northeast direction and outlet into the Lake of the Woods through Four Mile (Bostic) and Zippel Bays. The Canadian Pacific Railroad and Minnesota State Highway 11 run parallel to each other in a northwest to southeast direction across the upper third of both watersheds. Williams, population 191 (2010 census) is the largest city within the study area. It is located on Williams Creek within the Zippel Creek watershed along State Highway 11. The small community of Graceton is located along State Highway 11 near Canfield Creek within the Bostic Creek watershed.

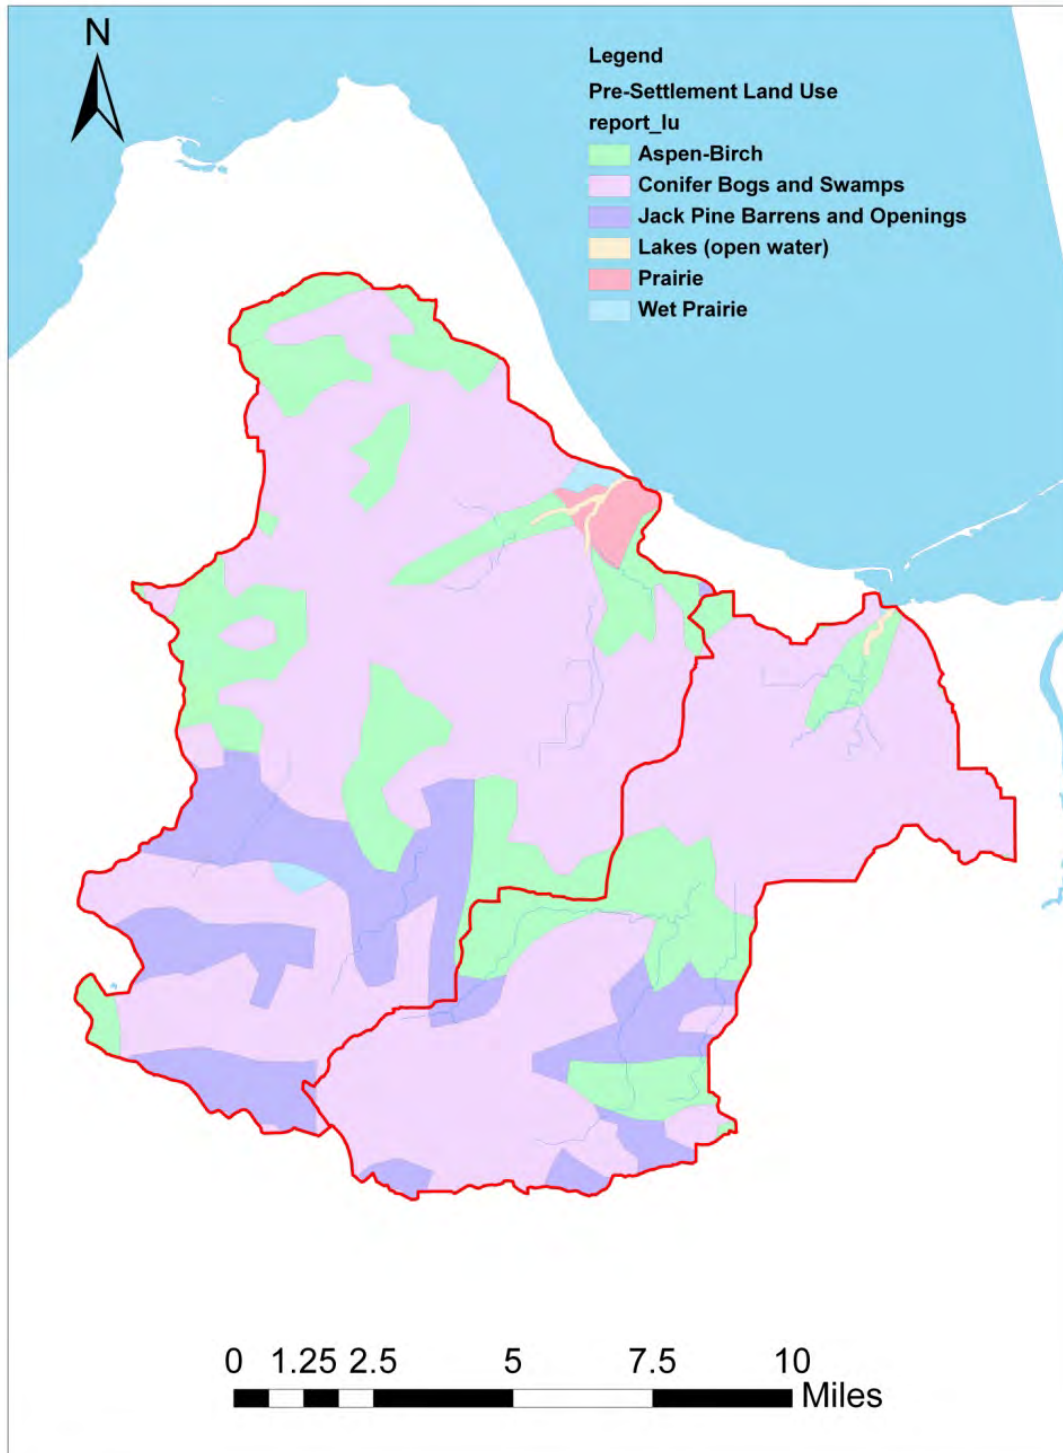
Figure 4 - Pre-Settlement Land Use

Figure 4 shows the general pre-settlement land cover of the two watersheds. This information comes from F.J. Marschner's 1930's compilation and interpretation of the State's original land survey notes. These notes were based on observations taken during 1848 - 1907. The figure shows a general pattern of Conifer Bogs and Swamps north and south of the beach ridge with Jack Pine Barrens-Openings and Aspen-Birch along the beach ridge itself. The lower reaches of Zippel and Bostic Creeks have an Aspen-Birch cover.

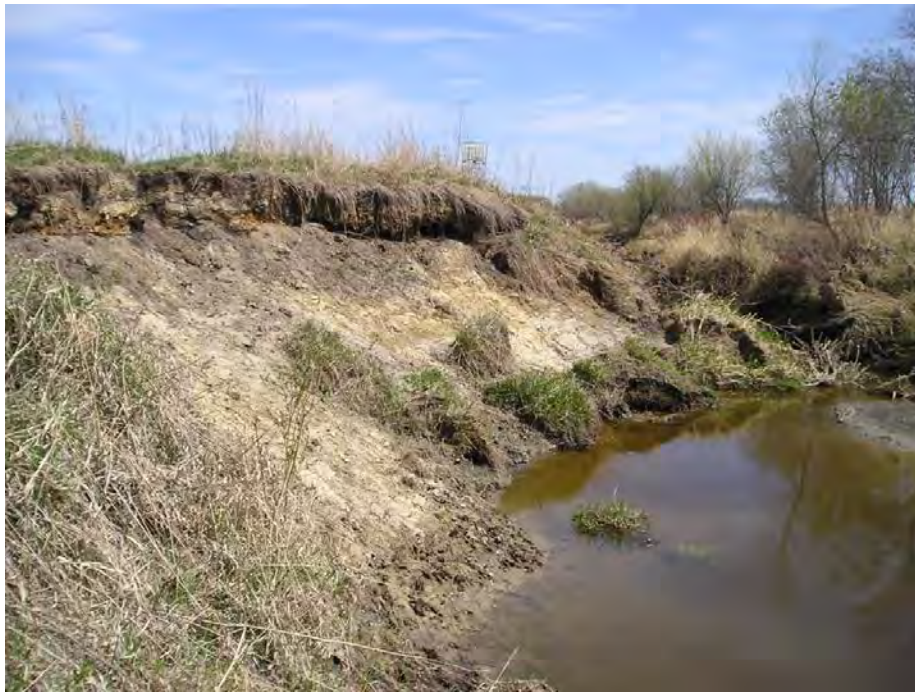
Figure 17 - Side Slope Erosion - JD28

Figure 17 is an example of side slope erosion on Judicial Ditch 28 prior to stabilization measures installed by the county.

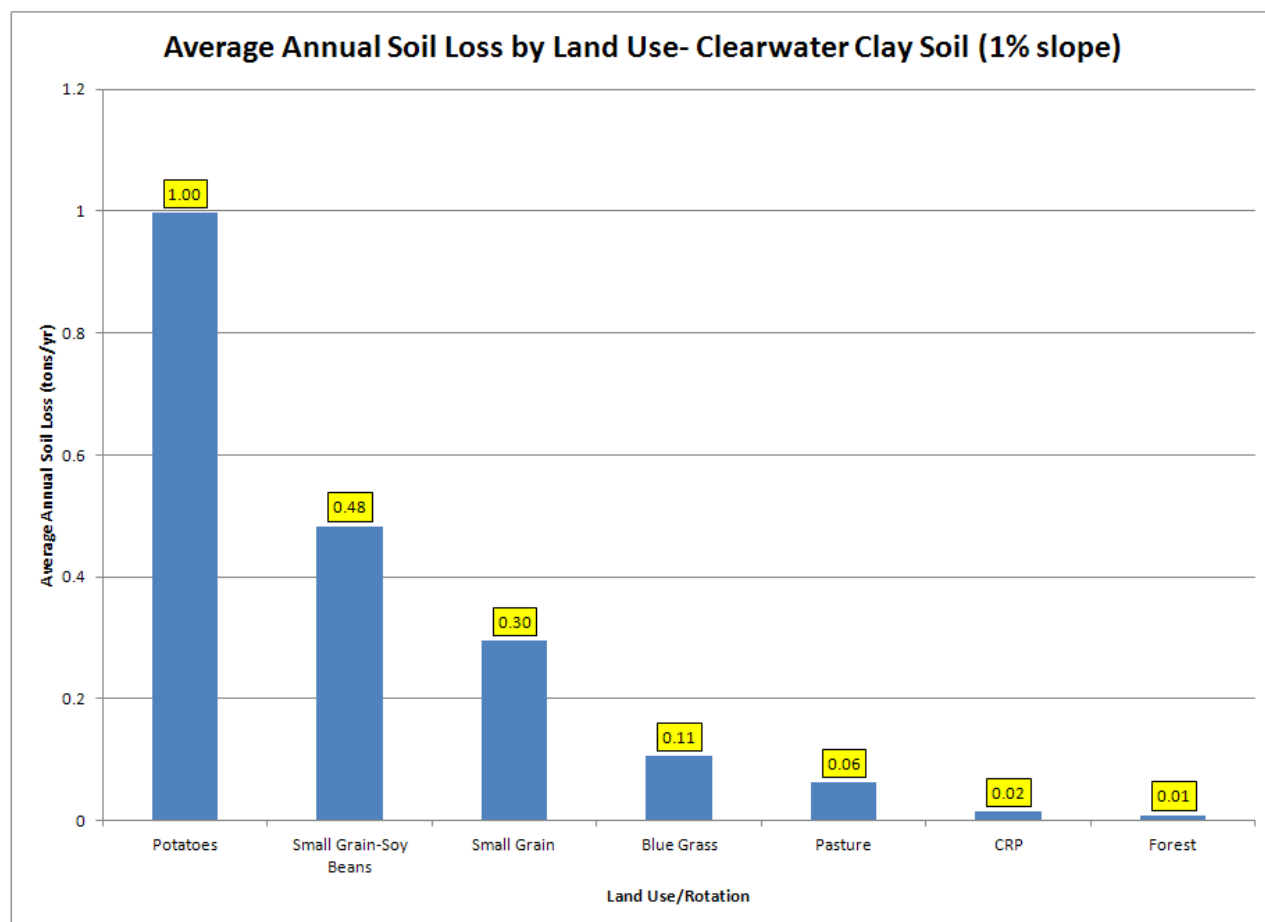
Figure 24 - Average Annual Soil Loss on Clearwater Clay Soil for Various Land Uses/Rotations

Average annual soil loss for various land uses/rotations on one of the predominant soils found in both watersheds (Clearwater Clay – 1% slope), is displayed in Figure 24. As can be seen in the figure, there are significant differences in soil loss depending on land use. For perspective, a few scenarios are summarized below:

- A field with a small grain/soy bean rotation has half the soil loss as a field with potatoes
- Converting a blue grass field to a small grain/soy bean rotation can quadruple soil loss
- Placing a small grain field into CRP can reduce soil loss by a factor of 15

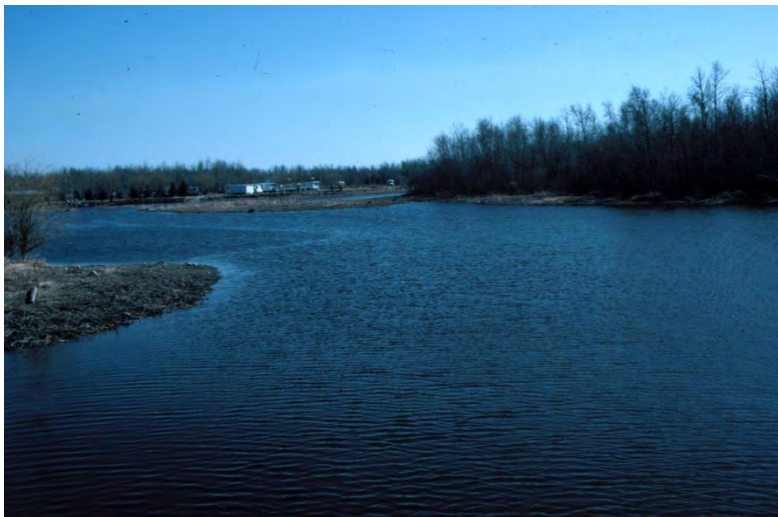
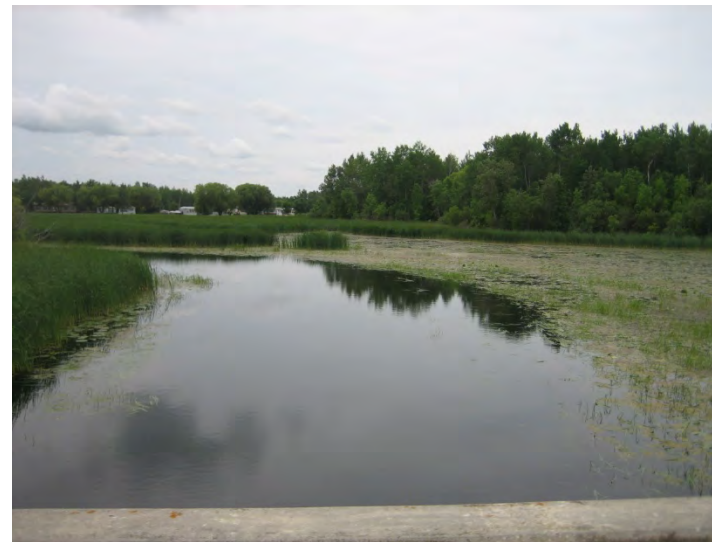
Figure 29 - Bostic Creek Looking Upstream from Co Rd 8 - 1983 and 2009

Photographs taken of Bostic Bay between 1983 and 2009 from County Road 8 clearly show a smaller open water area in the vicinity of crossing (see Figure 29 and Figure 30). Aerial photos were also used to establish patterns of open water sedimentation. Figure 31 and Figure 32 display South Zippel Bay and Bostic Bay, respectively during 1941, 1979, and 2009.

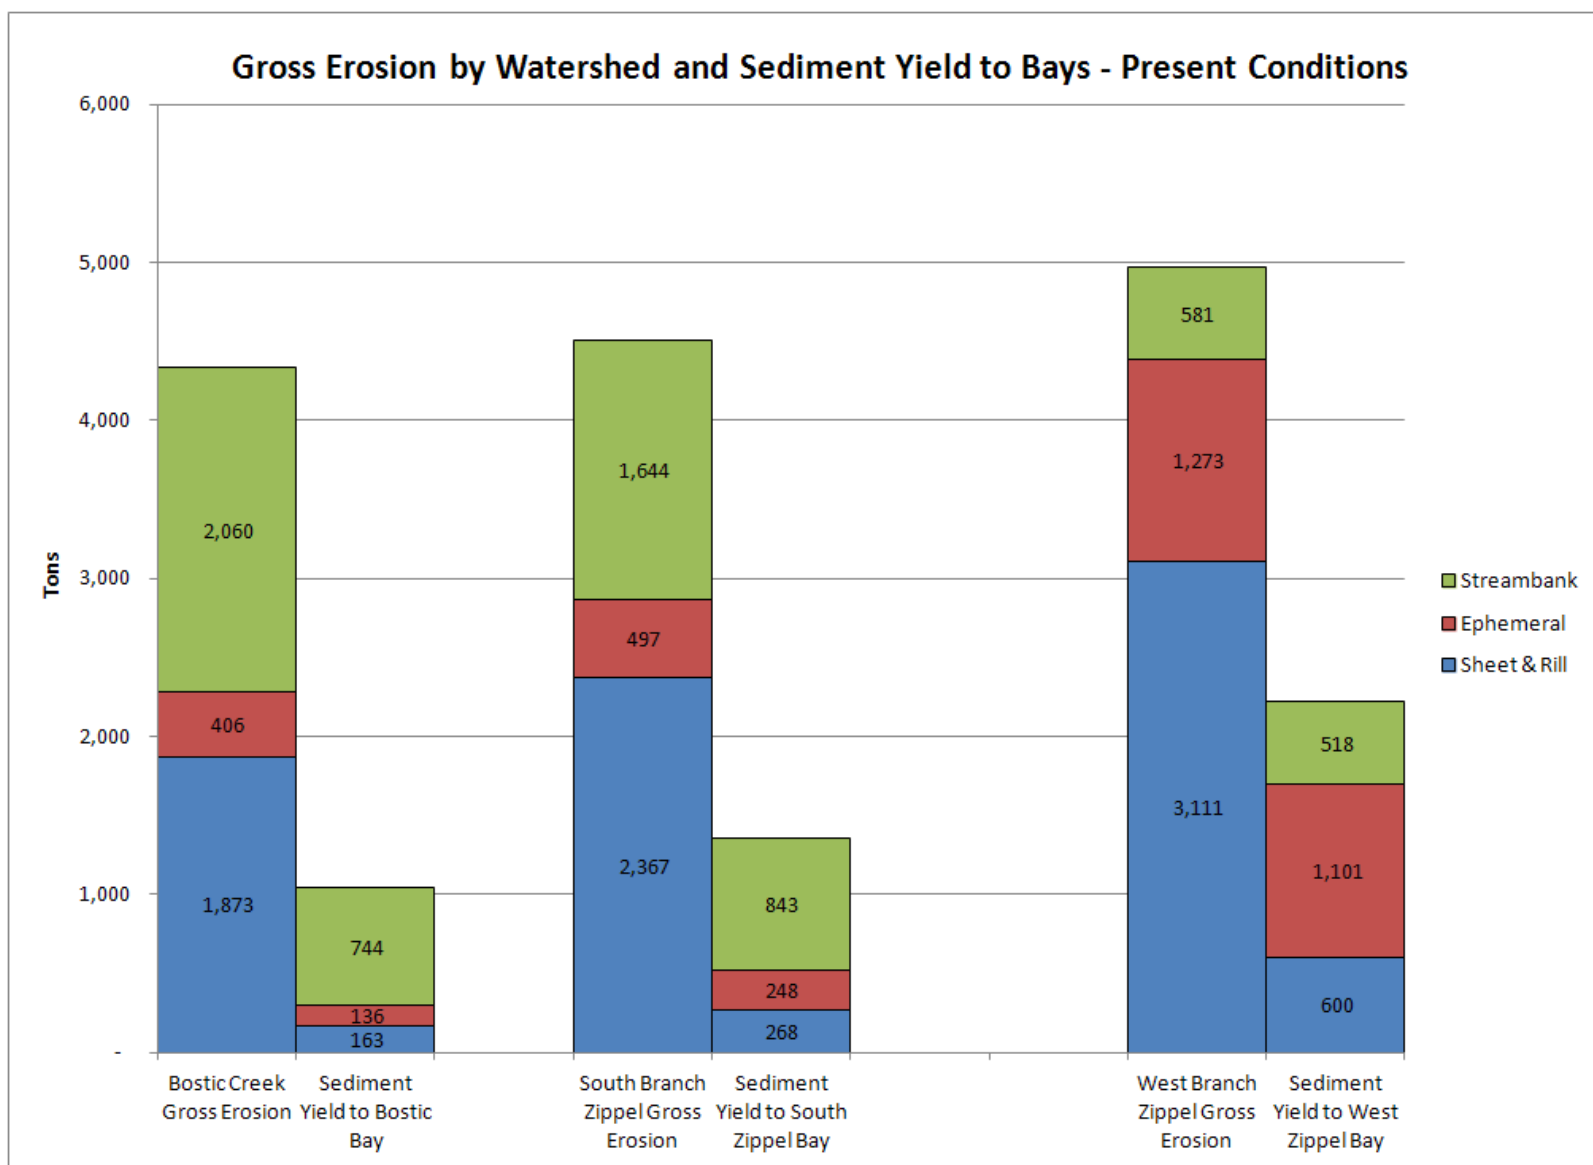
Figure 34 - Gross Average Annual Erosion and Sediment Yield to Bays

Bay	Sheet & Rill Erosion (tons)	Ephemeral Erosion (tons)	Streambank/Ditch Erosion (tons)	Total Sediment Yield (tons)	Percent of Gross Erosion Reaching Bays
Bostic Bay	163	136	744	1,043	24%
South Zippel Bay	268	248	843	1,359	30%
West Zippel Bay	600	1,101	518	2,219	45%

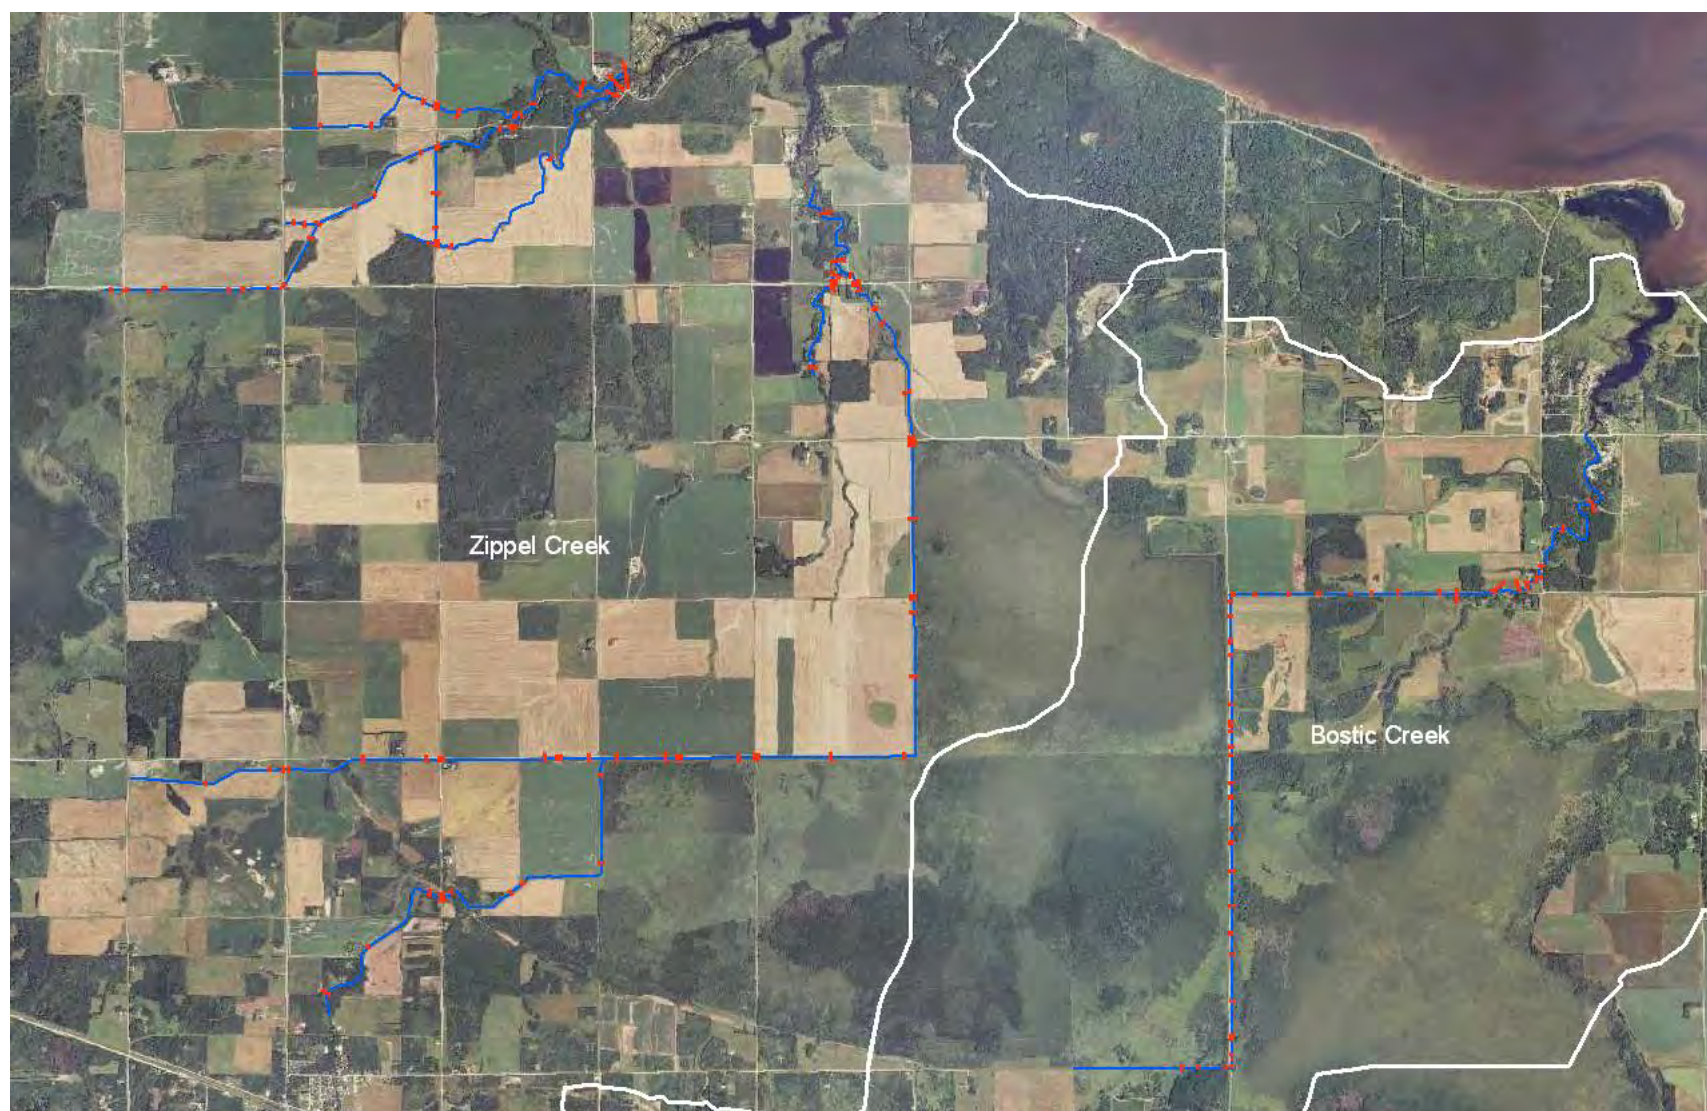
Figure I- 4 - Locations of Surveyed Cross Sections in Bostic and Zippel Creeks (in red)

HEC-RAS hydraulic models were also developed for Bostic, West Branch, and South Branch Zippel Creeks. These hydraulic models use data from 2007 and 2009 surveys of cross sections and culverts. See Figure I-4 for a plan view showing locations of cross section surveys. These models are very basic in nature and were used to make visual comparisons in channel shape changes from 1967 to today (see Appendix H). These HEC-RAS models are not of sufficient detail to accurately describe stage/discharge relationships along the ditch systems.
