Long Point Daily Observation: May 23rd, 2022

Long Point Daily Observation: May 21st, 2018

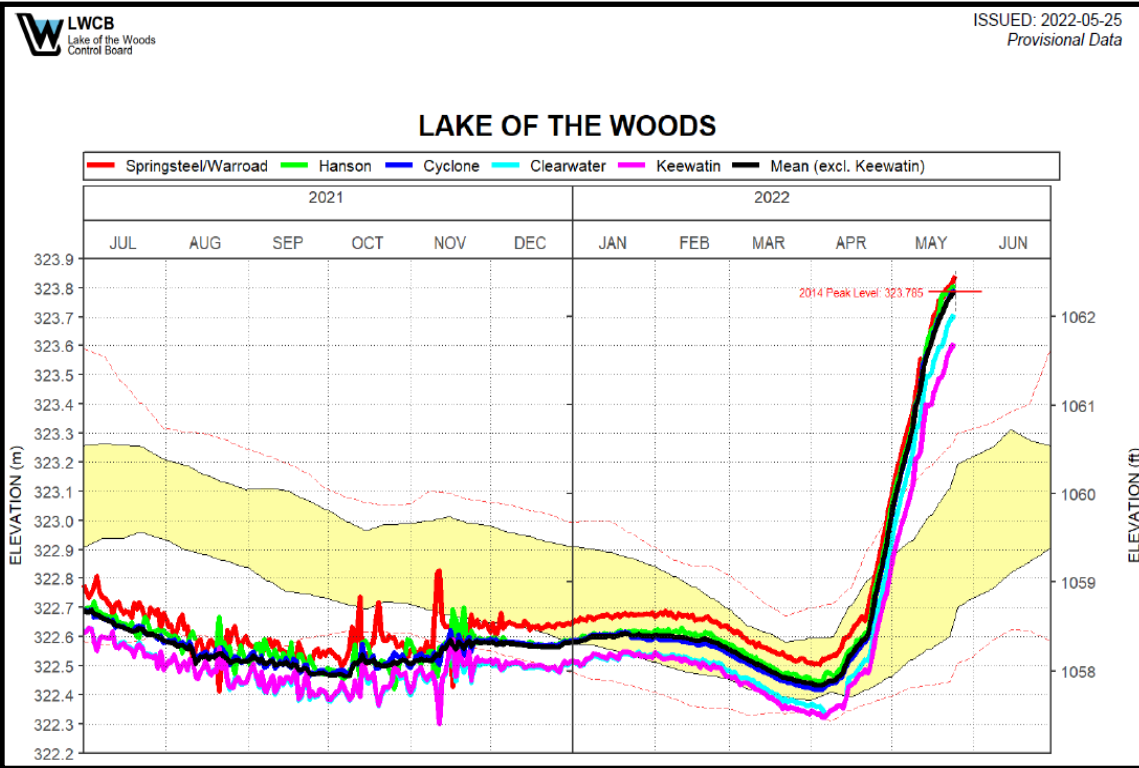
* yellow band is the targeted water level range

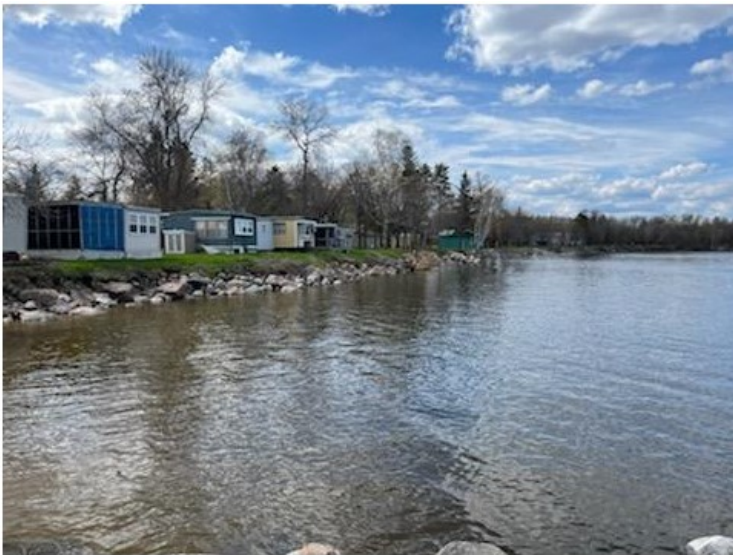
Facing NW

Observation Data	Date	5/23/2022
	Time	3:32pm
	Observer Name	Kelly Berggren
	Photos Taken	Yes
Weather Data	Wind Direction (Azimuth)	210
	Wind Speed (mph)	9.2
	Measured Speed (mph)	8.7
	Cloud Cover	25% Cover
Conditions/Water Level Data	Distance of Water from Toe of Slope	Water is Touching the Toe (Bottom of the Bank)
	Wave Description	Ripples
	General Satisfaction	Level is Very High, Shoreline is Threatened
	Volunteer Obs Water Level	1062.27
	Water Level @ Springsteel	1062.40
	Water Level Diff from Springsteel	0.13

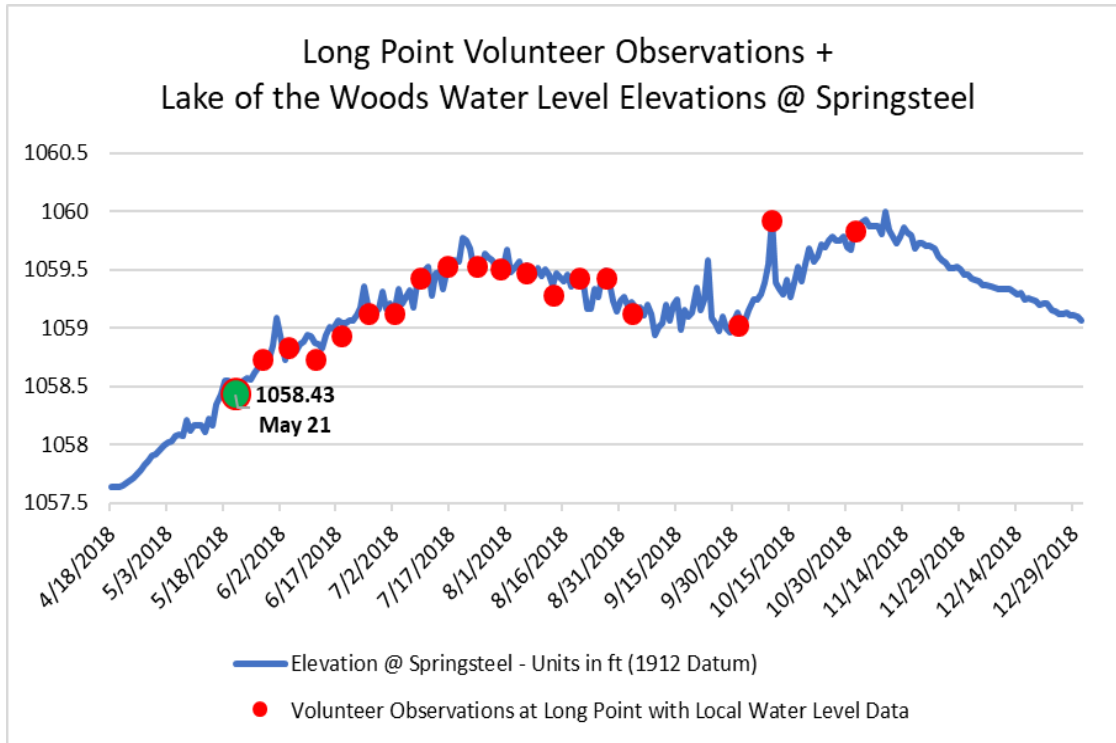
Observation Data	Date	5/21/2018
	Time	2:30pm
	Observer Name	Kelly Bergen
	Photos Taken	Yes
Weather Data	Wind Direction (Azimuth)	200
	Wind Speed (mph)	8.1
	Measured Speed (mph)	2.8
	Cloud Cover	Clear
Conditions/Water Level Data	Distance of Water from Toe of Slope	Greater than 10 ft from Toe (Bottom) of Bank
	Wave Description	Ripples
	General Satisfaction	Levels are Very Low, Inhibits Recreation or Makes Boating Difficult
	Volunteer Obs Water Level	1058.43
	Water Level @ Springsteel	1058.48
	Water Level Diff from Springsteel	0.05
