Graceton Beach Daily Observation: June 14th, 2022

Graceton Beach Daily Observation: June 12th, 2017

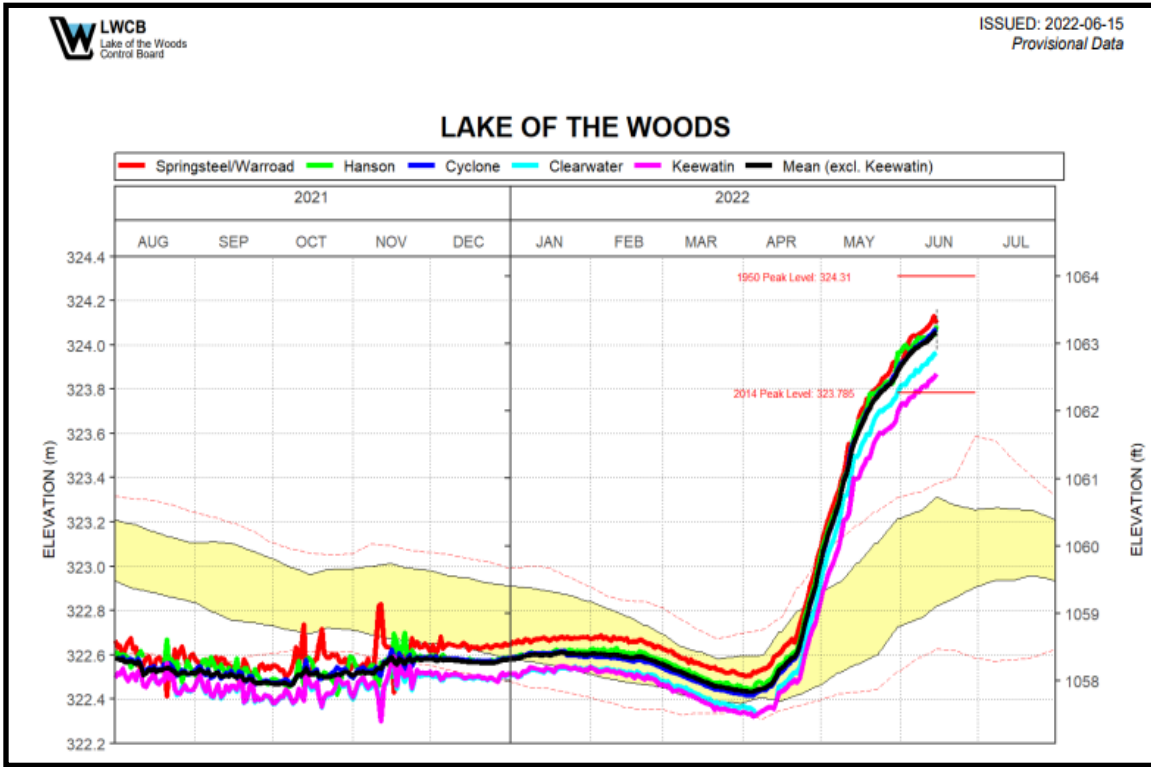
* yellow band is the targeted water level range

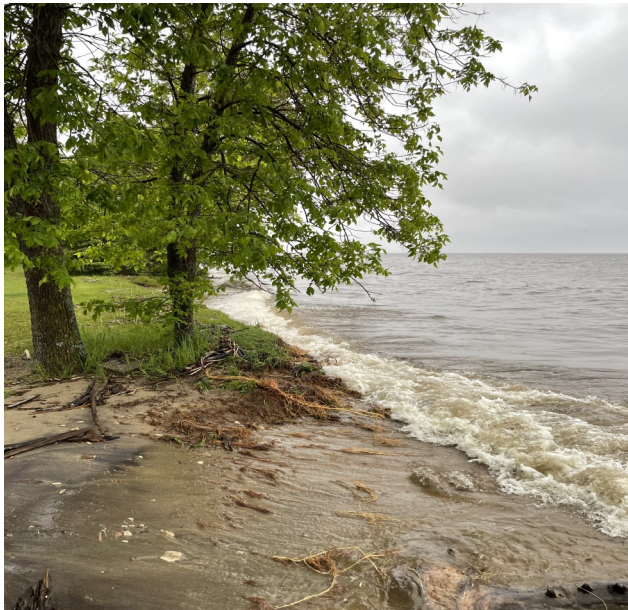
Facing W

Observation Data	Date	6/14/2022
	Time	9:00am
	Observer Name	Don Krause
	Photos Taken	Yes
Weather Data	Wind Direction (Azimuth)	40
	Wind Speed (mph)	13.8
	Measured Speed (mph)	3.3
	Cloud Cover	Overcast
Conditions/Water Level Data	Distance of Water from Toe of Slope	Other water is covering rocks and eating shoreline
	Wave Description	Medium Height, Some White Caps, Boating Possible
	General Satisfaction	Level is Very High, Shoreline is Threatened
	Volunteer Obs Water Level	NA
	Water Level @ Springsteel	1063.45
	Water Level Diff from Springsteel	NA

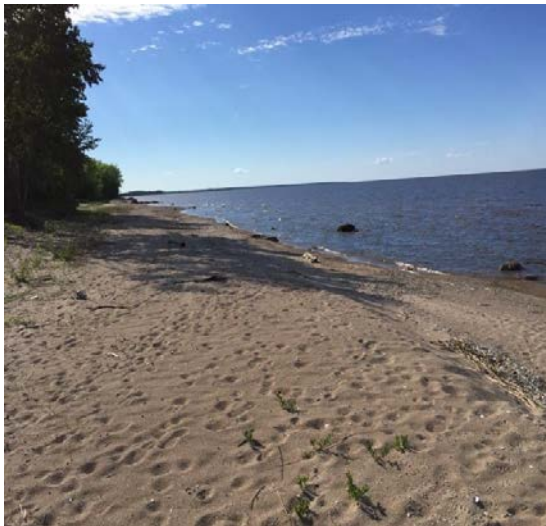
Facing NW

Observation Data	Date	6/12/2017
	Time	5:30pm
	Observer Name	Don Krause
	Photos Taken	Yes
Weather Data	Wind Direction (Azimuth)	110
	Wind Speed (mph)	9.2
	Measured Speed (mph)	4
	Cloud Cover	Clear
Conditions/Water Level Data	Distance of Water from Toe of Slope	Water is Touching the Toe (Bottom of the Bank)
	Wave Description	Ripples
	General Satisfaction	Levels are Good, Water Levels are Satisfactory
	Volunteer Obs Water Level	NA
	Water Level @ Springsteel	1059.08
	Water Level Diff from Springsteel	NA
